Geocomposite drains: what the eye can't see beyond lamination

By Gregory N. Richardson Ph.D., P.E., and Jack Boschuck, P.E.

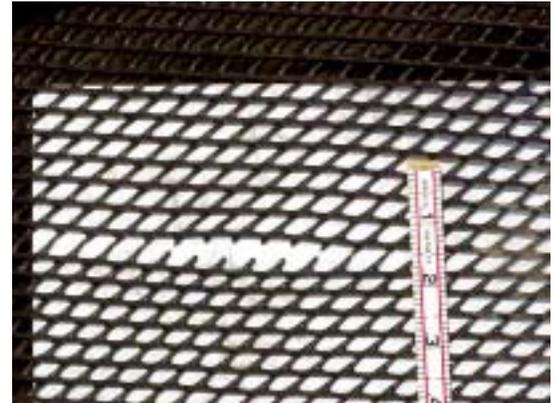
Photo 1. Though the problem is rare, close inspection of geocomposite drainage material at one job site revealed a damaged geonet core.

During the placement of a geocomposite drainage layer in a RCRA final cover at a Superfund site, the installation crew pointed out to the inspector that some rolls of the drainage composite appeared to have a 'broken' geonet. Closer examination of the geocomposite drainage material showed that the geonet core was indeed damaged. One layer of ribs was broken at the point of connection to the second rib. This is shown in **Photo 1**. It appeared that excessive tension in the geonet during lamination of the geotextiles had actually broken the geonet. The closer examination also showed that the breaks were visible in the composite as lines of depression in the geotextile as shown in **Photo 2**.

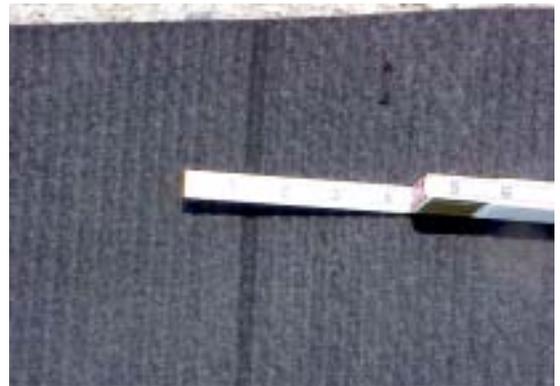
Photo 2. Lines of depression on the geotextile revealed further problems.

Once this defect characteristic was observed, the defects in 4.4 acres (1.8 ha) of exposed geocomposite drainage material were mapped by visually examining all exposed geocomposite. This mapping showed that 45% of the panels had no defects. The remaining panels had defects that ranged from full width (6.5% of the panels) to smaller but more numerous defects. The defective panels were removed and replaced with defect free composite. Unfortunately 20.1 acres (8.1 ha) of this composite drainage material had been installed and covered with the vegetative soil support layer so that defects could not be detected and removed. These hidden defects present a potential mechanism by which detrimental pore water pressures

Transmissivity tests performed on the defective geocomposite showed that flow was significantly reduced across the defect due to intrusion of the overlying soil. Intact drainage composite samples had a transmissivity of approximately $1.4 \times 10^{-4} \text{ m}^2/\text{sec}$. This was less than the required transmissivity of $3 \times 10^{-4} \text{ m}^2/\text{sec}$. Additionally, tests on defective geocomposite samples indicated that the flow capacity was further reduced by a factor of 66 by the presence of the defect. Such a dramatic reduction in flow capacity could obviously lead to a backup of water in the drainage layer and potential slope failure of the overlying vegetative support layer (Richardson 1997, and Richardson, Giroud, and Zhao 2002).

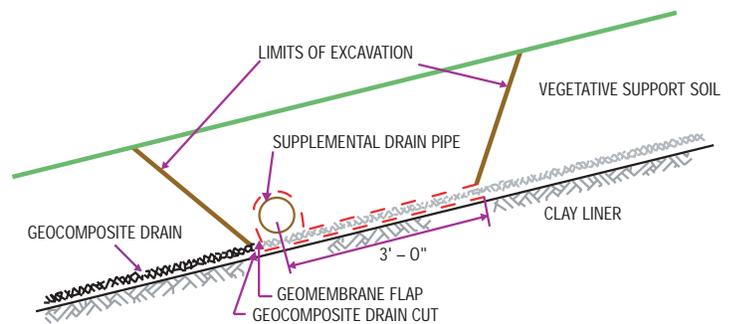
Figure 1. Supplemental drainage intercepts. A geomembrane flap is required to force the water draining in the geocomposite into the pipe.

The overall failure of the geocomposite transmissivity meant that drainage lengths constructed were excessive and needed to be reduced. This was accomplished by retrofitting additional collector pipes to reduce the length of drainage in the composite by three to only 41 ft. (12.5 m). **Figure 1** shows the detail of the supplemental drainage intercepts. Note that a geomembrane flap is required to force the water draining in the geocomposite into the pipe. These supplemental drainage intercepts were installed by trenching the vegetative support soils, cutting the drainage composite, and then installing the supplemental drain components.

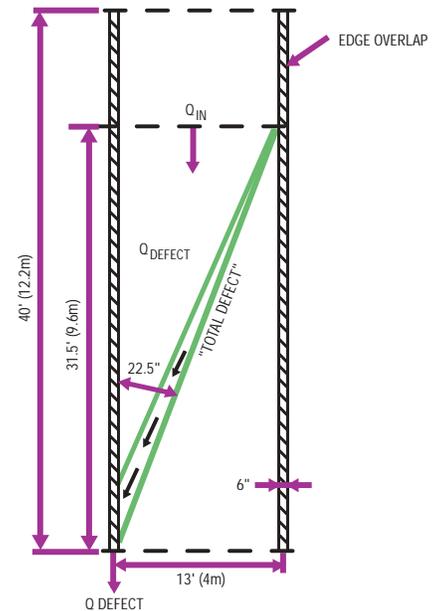
Next, the question of the impact of defects in the composite on the stability of the cover on the 4H:1V slopes had to be addressed. It must be noted that this question was never addressed to the satisfaction of all parties involved. The following approach is that used by the first author. **Figure 2** shows the worst potential drainage condition observed in the field mapping of geocomposite defects. Here the defect runs the full width of the panel. Conservatively modeling the defect as a total flow blockage, the maximum quantity of water, Q_{in} , that would impinge on this defect can be estimated by assuming a unit gradient inflow, $q_h = k_{soil}$. For this site, the vegetative cover soil had a permeability of $4.0 \times 10^{-7} \text{ ft}/\text{sec}$ ($1.2 \times 10^{-7} \text{ m}/\text{sec}$). The contributing area up-gradient of the defect is approximately $13(18.6 + 31.4/2) = 438 \text{ ft}^2$ (40.7 m^2). The total lateral drainage impinging on the defect is given by the product of q_h and the contributing area or $1.75 \times 10^{-4} \text{ ft}^3/\text{sec}$ ($4.9 \times 10^{-6} \text{ m}^3/\text{sec}$).

the defect indicated a transmissivity of $0.9 \times 10^{-4} \text{ m}^2/\text{sec}$. The flow gradient for flow parallel to the defect can be calculated to be 0.23. Given that the maximum flow capacity of a geonet is equal to the transmissivity time the gradient, the maximum width, w , of flow due to the total lateral drainage impinging on the defect can be calculated as follows:

This small width of confined flow will not create a slope stability problem and the repair is complete. Note also that the higher flow capacity strip between each geocomposite drain panel has a capacity of $0.25 \times 1.7 \times 10^{-3} \text{ m}^2/\text{sec} = 0.43 \times 10^{-3} \text{ m}^3/\text{sec}$. This is larger than the maximum total lateral drainage impinging on the defect. Thus, the flow moving down parallel to the defect has unrestricted drainage when it reaches the panel edge.

Figure 2. The worst potential drainage condition observed in the field mapping of geocomposite defects. Here the defect runs the full width of the panel.

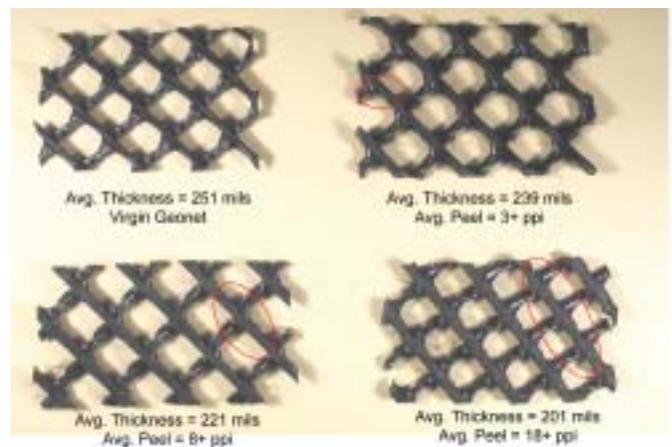
A closer look at this particular bonding process revealed that the higher heat coupled with increased bonding pressure resulted in damage to the ribs and loss of rib thickness. **Photo 3** shows the physical results

Photo 3. Peel strength vs. thickness for increasingly aggressive bonding heat and pressure. Transmissivity from 3 to 18 ppi products differed by nearly one order of magnitude.

of peel strength versus thickness for increasingly aggressive bonding heat and pressure. The difference in transmissivity between the 3 ppi peel strength product and that of the 18 ppi product was almost one order of magnitude. This reduction was attributed to the following:

- The pressure and heat reduced the thickness of the geonet by about 20%.
- The softened geonet resin squeezed laterally to reduce the capacity of the flow channels.
- The opposing 8 oz./yd.² fabrics squeezed together to close the flow channels.

Testing by other labs over the past decade has clearly indicated that peel strengths of 0.5 to 1 ppi are sufficient to prevent shearing of the fabric under load. This minimal peel strength also minimizes damage to the ribs and facilitates overlapping of adjacent geocomposites.
