LANDFILL REMEDIATION

GREGORY N. RICHARDSON, PH.D., P.E.
WESTINGHOUSE - EGS

FIRST U.S. CONFERENCE ON MUNICIPAL SOLID WASTE MANAGEMENT

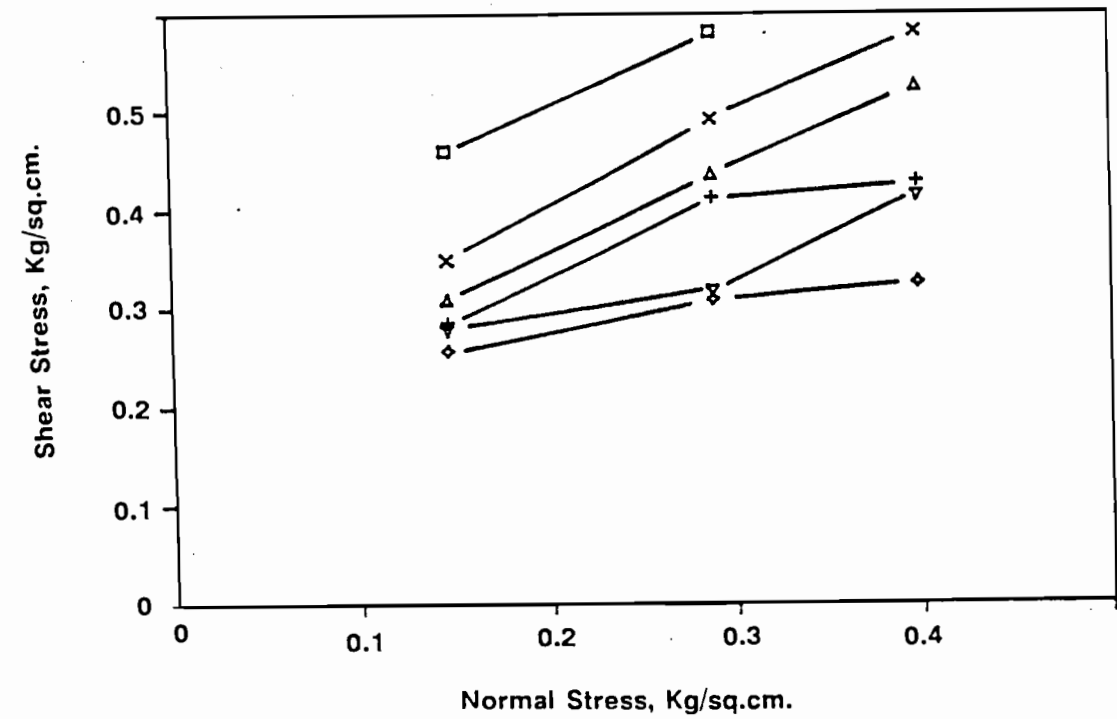
Figure 2 - MSW Direct Shear Test Results

To measure the shear strength of the trash, the owner constructed a 1.5m² square shear box. The box was loaded with large concrete blocks to vary the normal force in the test. Figure 2 provided a summary of the results.

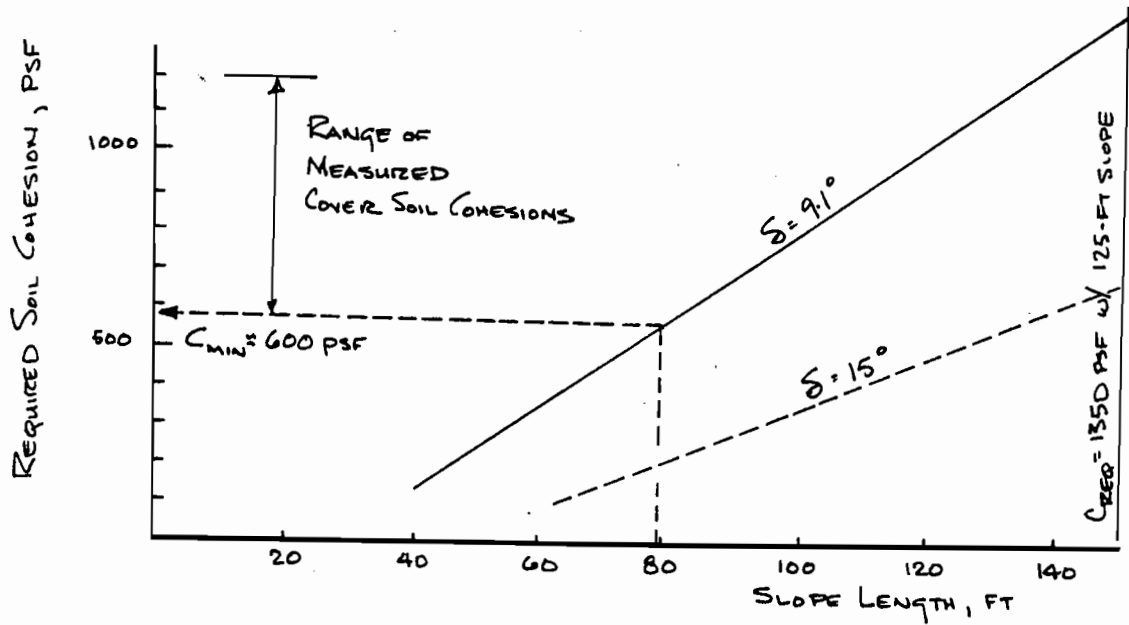
Figure 4 Cover Soil Shear Strength vs Stable Slope Length - Case 2

Just such a failure had concerned the design engineer. Early calculations indicated that the cover soil would be marginally stable if the slope length was less than 79 feet. To provide a greater margin of safety, the designer required that no more than 15 feet of cover soil be placed in advance of the waste.

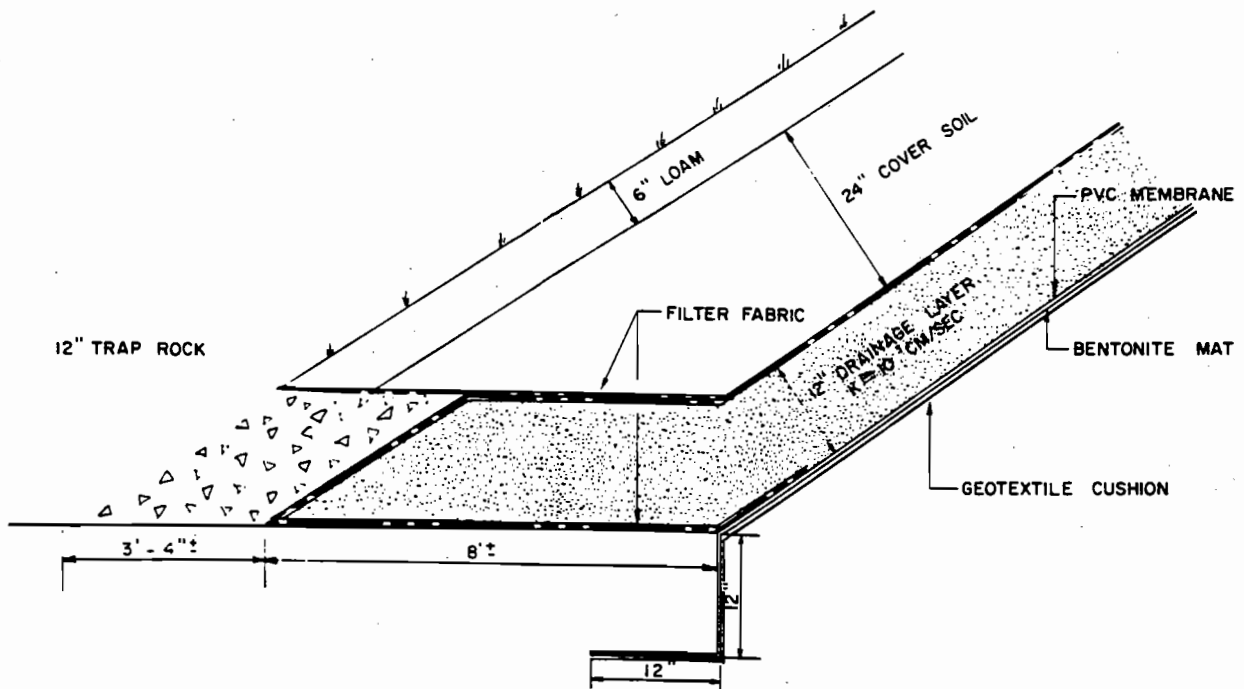
Figure 5 Initial CERCLA Cover System - Case 3

The design profile for this cover and the slope toe drainage detail are shown on Figure 5.

The low-permeability barrier was an effective composite formed by the 30-mil PVC geomembrane and the bentonite mat. However, the bentonite mat has an upper surface composed of a woven polypropylene geotextile. As in the previous case study, the coefficient of friction between a geotextile and a smooth geomembrane typically ranges from 9-12 degrees. Thus the cap profile constructed on the design 3H:1V slopes would either be unstable or would rely on the tensile strength of the filter fabric and the geomembrane.

While no failure occurred in this cap, the success was due to the small size of the cap and not to the technical ability of the designer. No stability calculations had been performed and no geogrid installation guidelines were prepared. Interestingly, the EPA review process did not detect these omissions.

Just prior to letting bid documents, a geogrid was added to the cover profile. The geogrid was placed immediately above the filter fabric and was intended to carry the weight of the
