# DESIGNER'S FORUM

## Fundamental mistakes in slope design

By Gregory N. Richardson

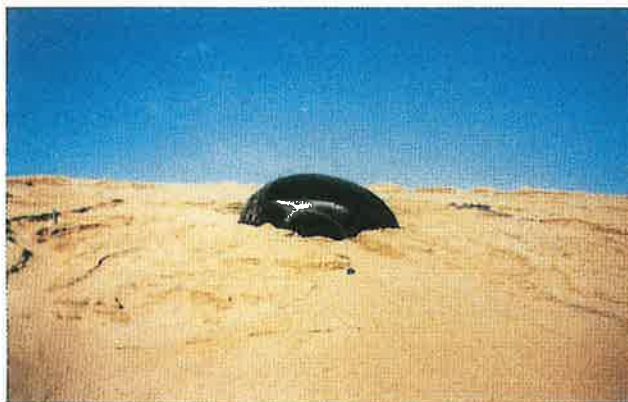
Photo 1 shows a small gas "whale" that developed during the construction of a fairly standard final cover. The designed final

Measurements made in one of the whales showed a gas pressure of an approximately 6 inch water column (0.21 psi or 31.2 psf). It was later shown that these pressures resulted from inadequate gas relief beneath the composite barrier. Neglecting seismic forces, the slope's stability can be evaluated using Equation 1 (next page). This model neglects toe buttressing forces and the tensile strength of the geosynthetic components. For the failure shown in Photos 1 and 2, we can assume that the cohesion is zero such that the slope stability can be expressed as:

Photo 1. This small gas "whale" developed during the construction of a fairly standard final cover.

1. Designers need to evaluate the stability of the cover as it is incrementally constructed.
2. Gas pressures *must* be effectively vented or relieved if a composite barrier is used on a slope.

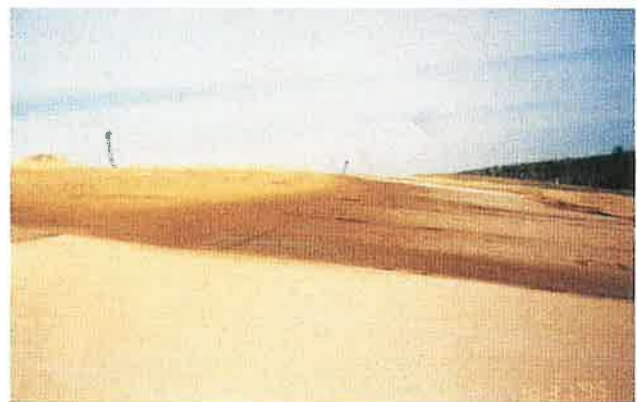
cover was to include a sand gas-collection layer, a composite barrier formed by a PVC geomembrane over a reinforced geosynthetic clay liner (GCL), an 18-inch-thick pore pressure relief system and a 12-inch vegetative-support layer. The system failed during placement of the pore pressure relief layer on the geomembrane (Photo 2). The sand drainage layer and the PVC geomembrane slid down the GCL. No movement of the GCL was observed.

Photo 2. Failure on this slope occurred during placement of the pore pressure relief layer over the geomembrane. The sand and PVC geomembrane slid down the GCL.

interface friction was greater than 17.5 degrees. Unfortunately, the measured interface friction angle was only 17 to 18 degrees, and a sliding failure resulted during placement of the sand drainage layer.

Note that the drainage-layer sand also could have easily slid due to its saturation, resulting in  $u \approx 90$  psf. The PVC geomembrane sliding, however, showed that the failed interface was between the geomembrane and the GCL. The significant lessons learned from this failure include:

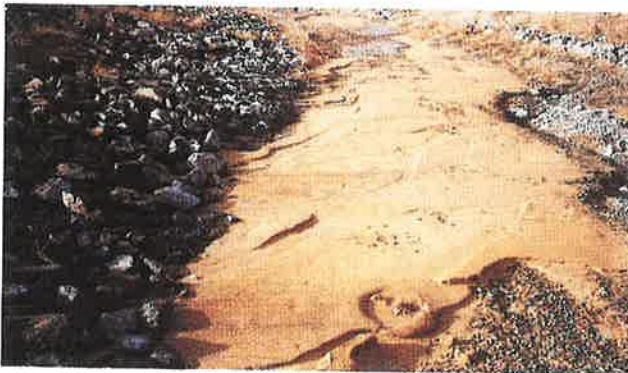
Photo 3 shows significant rills that formed when a very silty, fine-sand, vegetative-support layer "flowed" from a cover's side slopes (the slopes were as steep as 3H:1V). The final cover has 6 inches of topsoil, 18

Photo 3. This very silty, fine-sand, vegetative-support layer is "flowing" from a landfill cover's side slopes.

inches of the vegetative-support layer, and a single-bonded geonet drain over a geomembrane. Examination of the areas of failure showed that the geonet had not slid on the geomembrane—failure occurred at the interface of the silty sand vegetative layer and the geotextile bonded to the drainage net.

The silty sand had a friction angle of 31 degrees and was very fine (more than 30 percent nonplastic fines). The permeability of the silty sand was  $1 \times 10^{-4}$  cm/sec. A HELP analysis was performed to evaluate the geonet design and the moisture in the vegetative-support layer. The analysis indicated an acceptable inflow into the geonet and little change in the moisture content of the silty sand vegetative-support layer. Using the same slope stability analysis previously presented, Figure 2 shows the effect of saturating the sand and topsoil on the sliding factor of safety. The higher the saturated zone is allowed to rise in the cover profile, the lower the factor of safety. Given that the interface friction between the geotextile and the silty sand is less than the sand's shear strength (e.i.,  $\leq 30$  degrees), the factor of safety approaches unity for 3H:1V slopes if only the sand is saturated, and 4H:1V if the entire cover section is saturated.

Examination of the silty sand vegetative-support layer at the areas of failure showed that much of the silty sand was saturated. Such saturation results from the capillarity forces within the silty sand, and the capillary break formed at the geonet/geotextile/silty sand interface. The height of the capillary zone of saturation due to vertical infiltration into the silty-sand is more than

165 cm (65 inches) or more than the entire layer thickness. Recall that the HELP3 model does not incorporate capillary breaks so the vertically infiltrating water will continue to drain to the geonet even if capillary forces would prevent it in real life. It was clear, therefore, that the silty sand vegetative layer had saturated during the extremely wet weather the East Coast experienced the past two years. This dramatically reduced the sliding factor of safety and led to failure at the silty sand geotextile interface on the steeper portions of the slopes. Note that the silty sand layer will not begin to drain until it is saturated. Then, it will drain at a rate given by a unit vertical gradient.

1. The HELP model may significantly underestimate the saturation of layers above the lateral-drainage layer
2. The HELP model may significantly underestimate the rate of infiltration into the geonet by ignoring the capillary break, i.e., the unit gradient design method of lateral drains (Thiel, 1993) may be appropriate for lateral drains forming a capillary break.
3. Soils with a high percentage (> 15 percent) of nonplastic fines should be avoided on side slopes because the fines lead to saturation of the soil.
