## Surface impoundment design goals

This article describes a failure of a water storage reservoir. It provides a good reminder of design considerations that the author has previously recommended (Richardson 2000). With more than 4 decades of surface impoundment application experience to draw on, it would be reasonable to assume that typical designs have become routine with little opportunity for significant mistakes on the part of the designer. However, industry and personal experience show

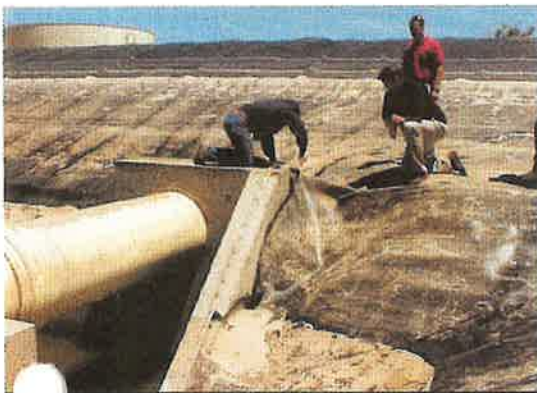
Photo 1 shows the extensive damage that was done to the HDPE liner during the final stage of hydrostatic testing immediately adjacent to a 30-in. (76.2-cm) water-inlet pipe. Extensive tearing of the geomembrane from the batten strips was observed and a significant volume of underlying soil had simply vanished. At this time, the designer suspected the quality of liner installation, the installer questioned the heritage of the designer, and the owner had lost confidence in all involved.

Photo 1: A significant length of geomembrane was pulled from the batten strip.

- During the third stage of filling, the pond liner system developed a small leak near the 30-in. inlet pipe. This leak could have occurred due to a defect in a seam weld of the liner, a leak of the seal used to seal the 30-in. pipe to the concrete, or a leak in the batten connection of the geomembrane to the concrete. After failure, the liner was so distressed that its initial condition could not be confirmed.

layer was removed, support of the geomembrane was lost and the geomembrane was forced to carry the weight of the water. **Photo 1** shows the significant length of geomembrane that was pulled from the batten strip as the underlying bedding layer eroded away. Once this degree of separation occurred, the water could easily move beneath the geomembrane since HDPE geomembrane actually floats in water (specific gravity at 0.95) and would not impede the water's flow. This resulted in scour of the smaller particle-size fraction adjacent to the concrete base wall. The geotextile cushion immediately beneath the geomembrane was wet and had been exposed to water.

- The use of such details as battens and conventional pipe penetration details that cannot be leak tested must be avoided. All components of the containment system must be pressure or vacuum tested.
- The liner must be protected from harm during its surface life. Thus, if you can see the geomembrane, you must assume that you will get a defect and resultant leakage during the liner's service life. It is more reasonable to assume that the surface impoundment liner has a very minor rate of leakage and design to accommodate that leakage as follows:

- If the contained liquid may harm the environment, then a secondary liner/collection system should be used to monitor the performance of the primary liner.
- If the contained liquid will not harm the environment, then the ability of the leakage to drain away from the bottom of the liner must be ensured. This may require a designed underdrain where natural subgrade soils have a low permeability.

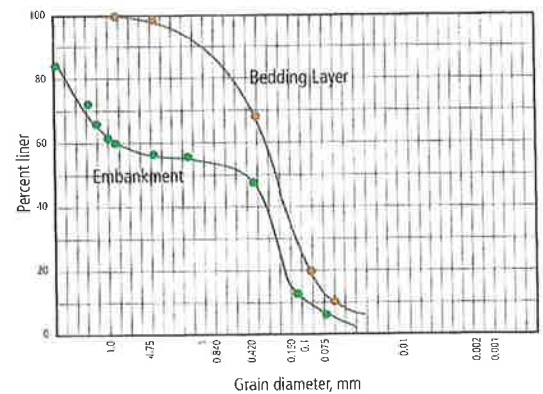
Figure 1 presents grain-size curves of the bedding soil and embankment material obtained in the immediate vicinity of the 30-in. (76.2-cm) pipe liner penetration. The embankment material is clearly gap graded (lacking coarse sand) but has approximately 50% of the smaller particle-size fraction. Since the material is non-plastic, the smaller particles consist of fine sand and silt.

**Figure 1:** Grain-size curves of bedding soil and embankment material around the pipe liner penetration.

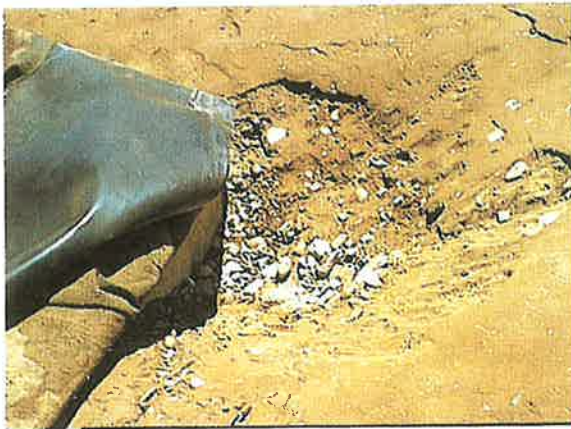
The impact of the lack of the coarse sand fraction in the materials must be understood to appreciate both the cause of failure and the goal of the repair work that will be required. As water flows through a soil, it will tend to remove the smaller-sized particles such as silts and fine sands. These smaller noncohesive particles are normally prevented from movement in a broad graded soil by the coarse sands. Additionally, the smaller particles can be restricted in movement if they constitute a majority of the material such that the coarse particles essentially float in the smaller particles, preventing the existence of large fluid pathways. However, Photo 2 shows the observed loss of soil beneath the HDPE liner apparent when the liner is removed.

- As the head of water acting on the defect increased, so did the rate of leakage through the liner. Water flowing beneath the liner mobilized the fine sand and silt particles of the bedding layer. This slurry was able to pass through those areas of the embankment that did not have a high percentage of the smaller particle size fraction. **Photo 2** shows the southwest corner of the facility immediately after removal of the geomembrane. The bedding layer's scouring through the coarse subgrade is evident.

**Photo 2:** Scour of bedding layer is evident after geomembrane removal.
