Lessons learned from failure: landfill covers

Developing better drainage systems for cover side slopes by studying failed ones

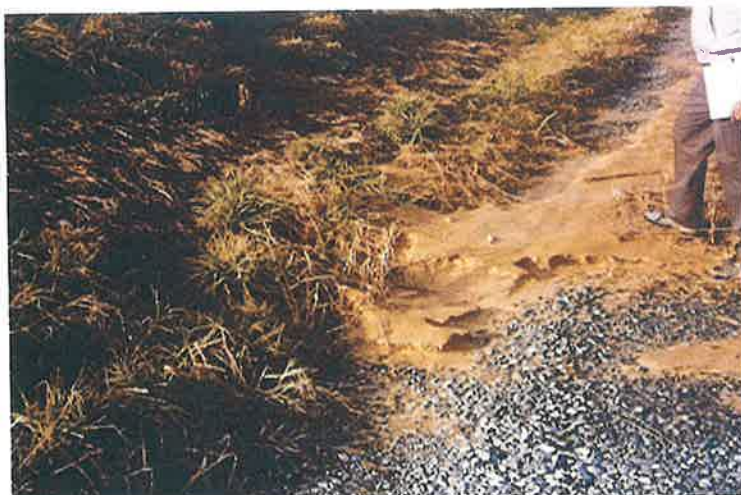
In the spring of 1996, United States Department of Defense (USDOD) officials conducted a routine inspection of several recently constructed landfill covers at a U.S. Navy installation. While inspecting one of the landfill covers, engineers noticed that a relatively minor amount of soil had migrated from the vegetative support layer of the cover system and deposited along a road at the perimeter of the landfill (Photo 1). Further inspection revealed several small erosion gullies on some of the steeper slopes of the landfill cover surface. In general, the vegetation on the cover was in excellent condition, and initially this appeared to be a simple erosion problem. Previous measures to address the erosion, including placement of riprap along the toe of the steepest slopes and some drainage feature modifications, appeared adequate.

Photo 1. Silt drainage at toe of slope.

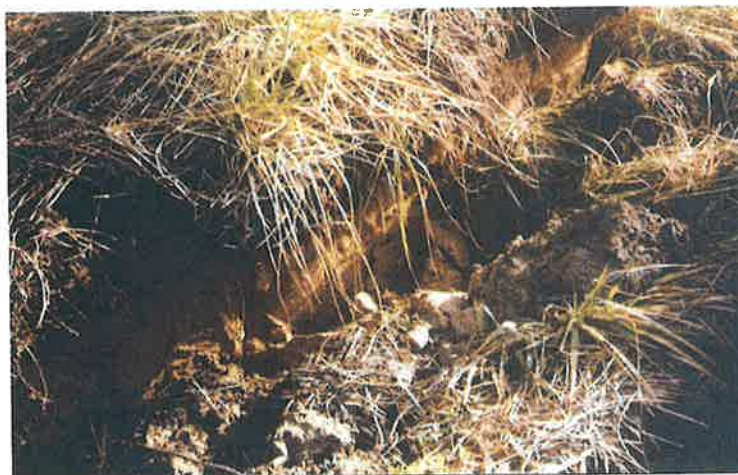
Photo 2. Crack observed in cover.

The repairs proved to be unsuccessful, and major drainage problems at the site continued. By the fall of 1996, significant new cracks were observed in the steep slope area of the landfill (Photo 2).

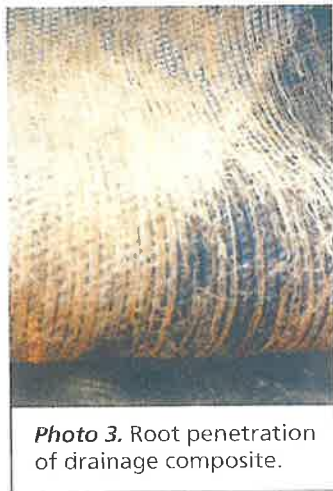
Photo 3. Root penetration of drainage composite.

Additionally, the recent removal of the old geocomposite drainage system during reconstruction exposed many areas of the drain that were totally clogged by root penetration (Figure 3). Root penetration had not been detected during either of the failure studies. This raises concern regarding the common thickness of soil layers above the lateral drain and the limitations of current transmissivity reduction factor. For this site, the 60 cm (24 in.) soil depth was not adequate to prevent grass root penetration. This is, however, a typical cover soil thickness and indicates that root penetration could be a larger problem than currently recognized. Based on this example, the authors recommend that a minimum factor of safety of 8 should be used in Equation 5 to determine the transmissivity of a lateral composite drainage element in a final cover. While no research data is available to support the premise, the authors feel that a very conservatively designed drainage layer would not contain sufficient free moisture to draw the roots into the drainage net.

- The potential for root penetration into the geocomposite must not be neglected. This may require evaluation of roots

depths of plants native to the site and corresponding adjustment of the cover soil thickness. Additionally, it is felt that an over-designed drainage layer will not contain sufficient available moisture to attract roots.
