Landfill closure: A lesson in crisis management

Set in the beautiful coastal lands of the eastern Chesapeake Bay, the small landfill had served Somerset County, Maryland from 1977 to 1997. The site was flat, sandy, with groundwater near the surface. As with all municipal solid waste (MSW) landfills of this age, no liner or leachate collection system was present beneath the waste. The state's Code of Maryland Regulations (COMAR), issued by the Maryland Department of the Environment (MDE), required a low permeability layer, such as a geomembrane, in the final closure cap to limit infiltration.

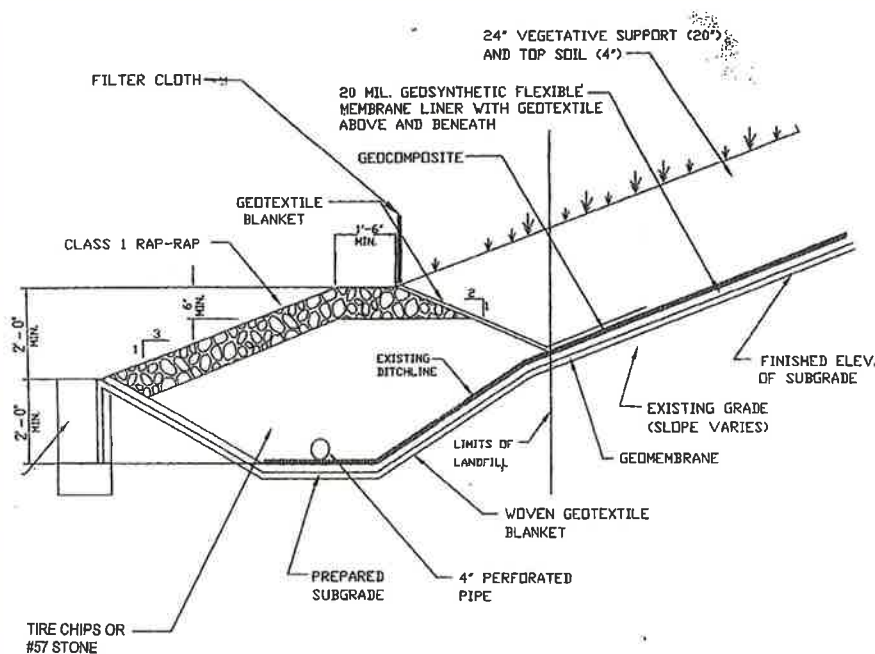
Figure 1. Original gravel drain at toe of slope.

The ability to construct the side slopes of the panhandle bottom-up was compromised by both the tight property lines and the presence of a large gravel drain at the toe of slope. This detail is shown in Figure 1. The property line was only 5 ft. from the edge of riprap for much of the perimeter.

The contractor did not believe that it was possible to construct and then remove a construction road around the base with this drain present.

- The simplest change was to incorporate a permanent access road at the base of the slopes such that bottom-up construction could be used. Photo 4 shows the roadway incorporated in the revised detail at the base of the slopes. As an additional benefit, the damaged drainage composite that had been removed from the cover was placed in layers beneath the roadway. This provided inexpensive disposal and reinforced the sands beneath the roadway.

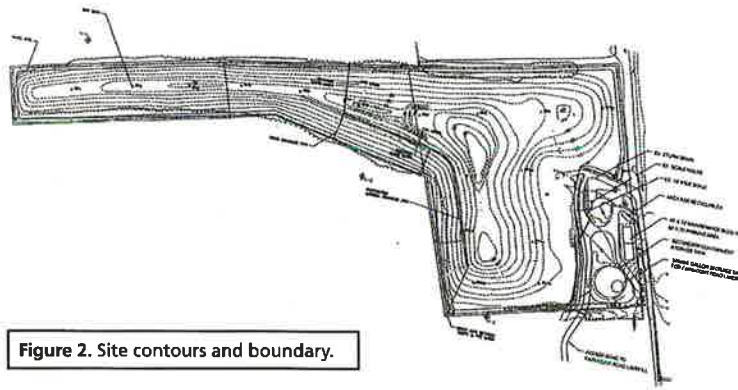
Figure 2 shows the contours and site boundaries. The cell's shape was reminiscent of Oklahoma, which complicated the closure design with the tight property boundaries. The side slopes were intended to be as steep as 3H:1V (33%).

Figure 2. Site contours and boundary.

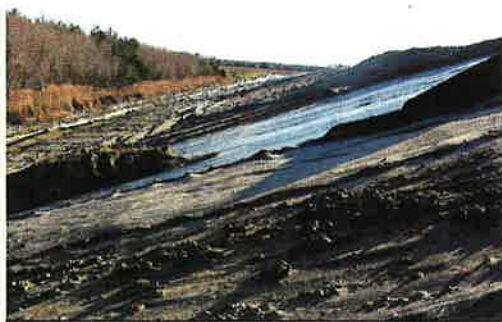
and other heavy equipment. When this was complete, the contractor planned to push soil downslope. The ridge of the panhandle was covered with approximately 4 ft. of cover soil material to allow dump trucks to back out onto the ridge of the panhandle. During the process of extending this roadway, a portion of the roadway slid off of the top of the slope and moved downward. **Photo 1** shows the slide and indicates that the failure interface was between the PVC geomembrane and the overlying drainage composite. Shortly thereafter, on the southwest portion of the site, another slope failure occurred when the contractor was using off-road equipment on the side slope of the landfill without first completing the perimeter road system in this area.

Both the contractor and MES brought in geotechnical consultants to evaluate the stability of the final cover under the actual field conditions. Several factors were thought to play a major role in the failure:

- The slope was steeper than the 3H:1V (33%) assumed maximum.
- The interface friction between the PVC geomembrane and the drainage composite was only 18.4° with a minimal adhesion of 10 psf.
- The top-down construction eliminates the toe buttressing of the soil veneer and lowers the sliding factor of safety.

Photo 1. Initial slope failure.

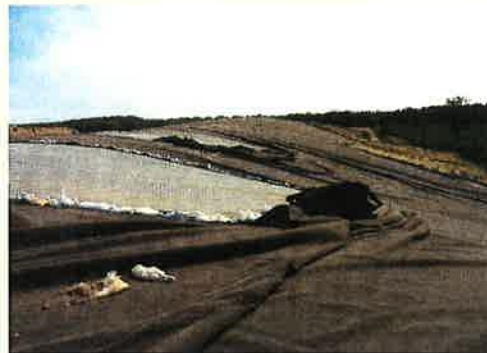
Photo 2. UV degradation of drainage composite.

As a result of the delay in completing the construction, all of the exposed geotextile forming the top of the drainage

composite had completely lost its integrity. The fabric was easily torn by hand and easily removed from the geonet core. Those areas immediately adjacent to the hot air seams were particularly quick to deteriorate (Photo 2). The geonet cores of the drainage composite were joined by white nylon ties on 5-ft. centers. Once the geotextile deteriorated, the direct sunlight quickly made the ties brittle and weak. Soon the drainage composite panels were no longer tied together; they acted independently. All exposed drainage composites had been damaged by the ultra violet (UV) light. They were removed and disposed of in another portion of the closed landfill.

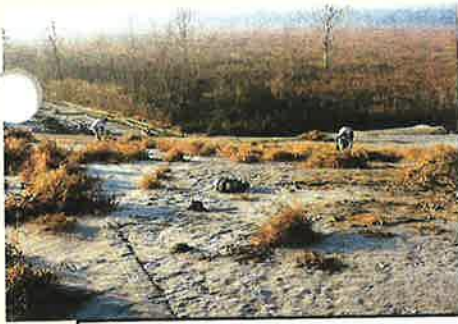
Photo 3. Invasive grass in exposed geotextile.

The removal process was complicated by the presence of invasive grasses that had rooted tightly to the drainage composite (Photo 3). All of this vegetative material had to be removed by hand prior to the placement of new materials.

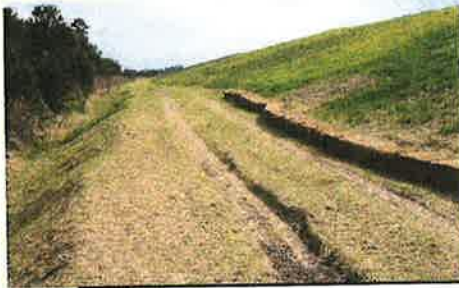
Photo 4. Perimeter roadway.

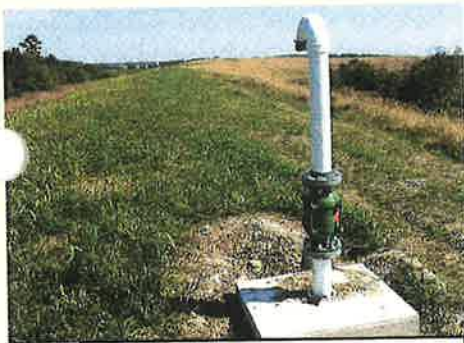
Photo 5. Final cover today.

These three simple changes allowed the side slopes of the panhandle portion of the landfill to be easily completed. Photo 5 shows the final cover as it exists today. Most of this cover was placed during what was for the region its wettest summer since 1948. In general, there were more rain and rain clean-up days than actual construction days. The stability of the slopes under conditions of near total soil saturation was well demonstrated.
