Active LFG Control: An Unreliable Aid to Veneer Stability

Gregory N. Richardson, Ph.D., P.E.
Stacey A. Smith, P.E.
Pieter K. Scheer, P.E.

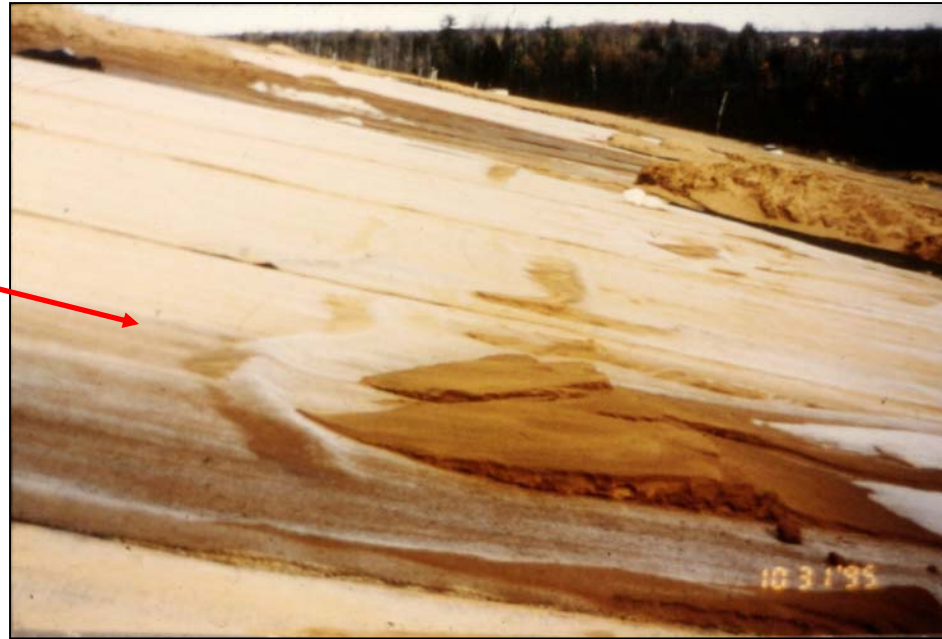
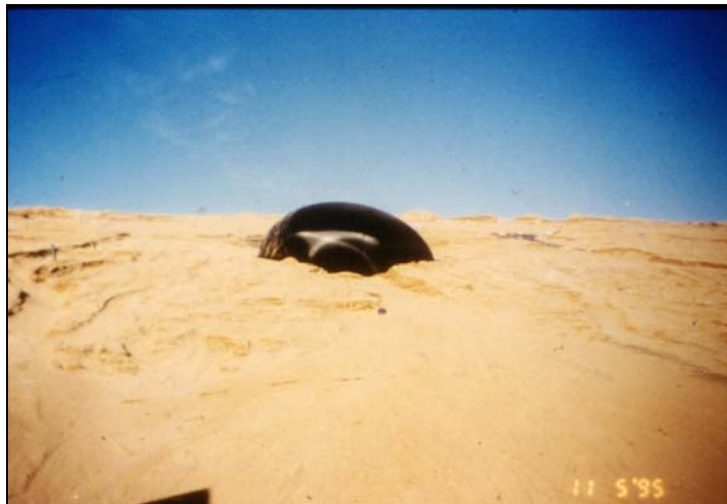
Exposed
GCL

- Failure occurred along PVC geomembrane/GCL interface before placement of final 1.5-ft of soil.
- PVC GM/GCL interface ($\phi = 16$ degrees; $a = 11$ psf) (not very robust) theoretically stable ($FS > 1.0$) at < 10 inch- H_2O LFG pressure.
- Average LFG pressure of 6.6 inch- H_2O and a maximum LFG pressure of 16 inch- H_2O were measured after failure.

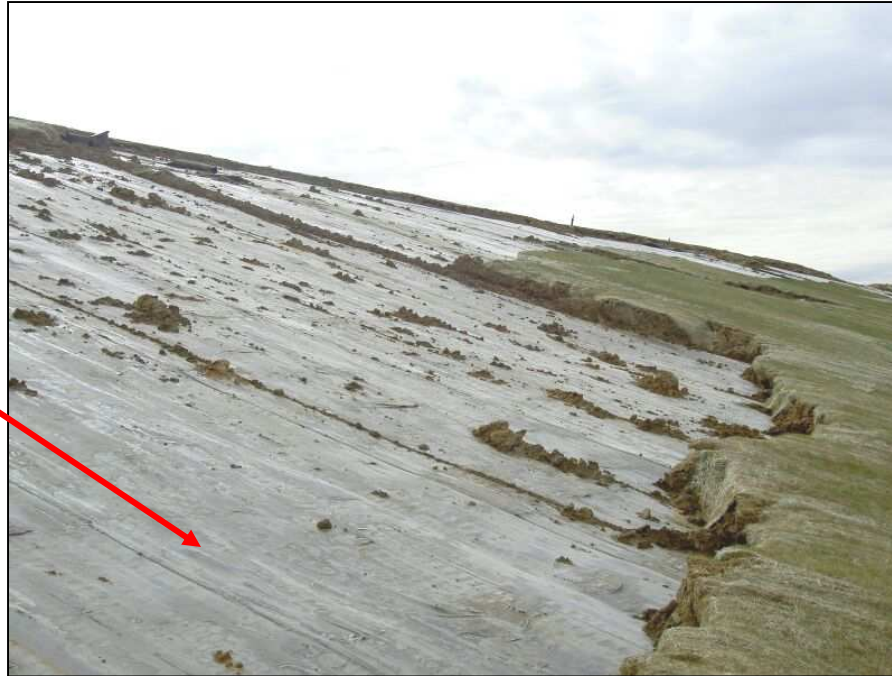
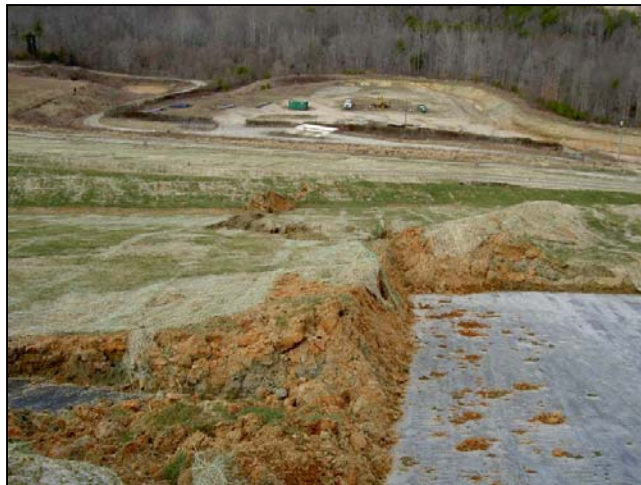
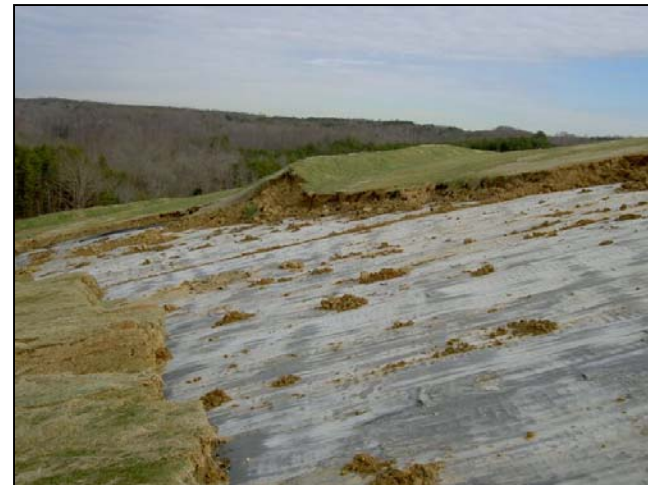
Exposed
GCL

- Failure occurred along LLDPE geomembrane/GCL within a few months of completion of the final cover system. The LLDPE geomembrane used was a structured product with conical spikes on the bottom and a studded drain layer (in conjunction with the nonwoven geotextile) on top.
- At the time of discovery of the failure, the active gas recovery system had been down for about one week for maintenance.

- Pre-construction testing of LLDPE GM/GCL interface ($\phi = 29$ degrees; $a = 0$ psf) theoretically stable ($FS > 1.0$) at < 15 inch- H_2O LFG pressure.
- Post-failure testing of LLDPE GM/GCL interface ($\phi = 23.5$ degrees; $a = 0$ psf) theoretically stable ($FS > 1.0$) at < 9 inch- H_2O LFG pressure.
- The significantly lower interface shear strength was attributed to dragging of the geomembrane downslope during deployment. The dragging reduced the asperity height of the spikes (i.e. dulled the tip of the spike).

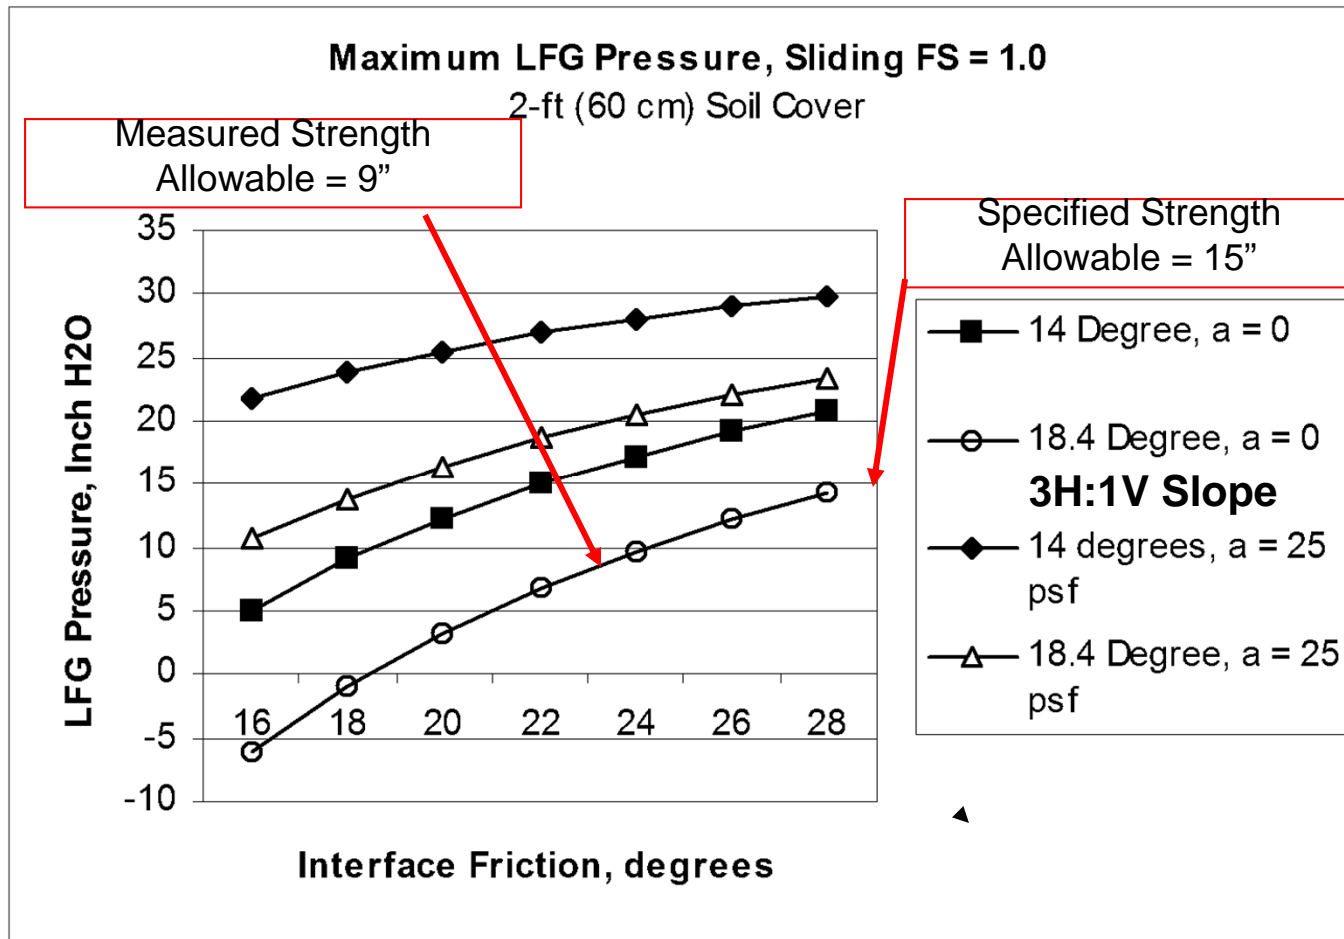
- To evaluate the effect of the active LFG system shutdown, a single recovery well was removed from an active LFG system and the subsequent increase in LFG observed.
- From an initial vacuum of 9-inch H₂O, it took only one hour to achieve a zero pressure. Over the next five (5) hours, the LFG pressure increased to 1.5-inch.
- Thus, **over a 10-inch increase in LFG pressure required less than six (6) hours.** This increase occurred despite the presence of adjacent LFG wells that remained in service and under the full operational vacuum.

- Conservative design would assume that **full LFG pressures would develop in less than two (2) days** if the entire active LFG system shuts down.
