**Composite Liner, Leak Detection System, and Floating Cover for
Nuclear Reactor Emergency Retention Basins**

R. H. Sentelle and G. N. Richardson

Summary: Existing reactor effluent basins are being retrofitted with composite liners, leak detection system and floating covers. Such basins have a 15-year life and remain empty until an accident occurs. The retrofit must not interfere with ongoing operations and must provide for integrity testing.

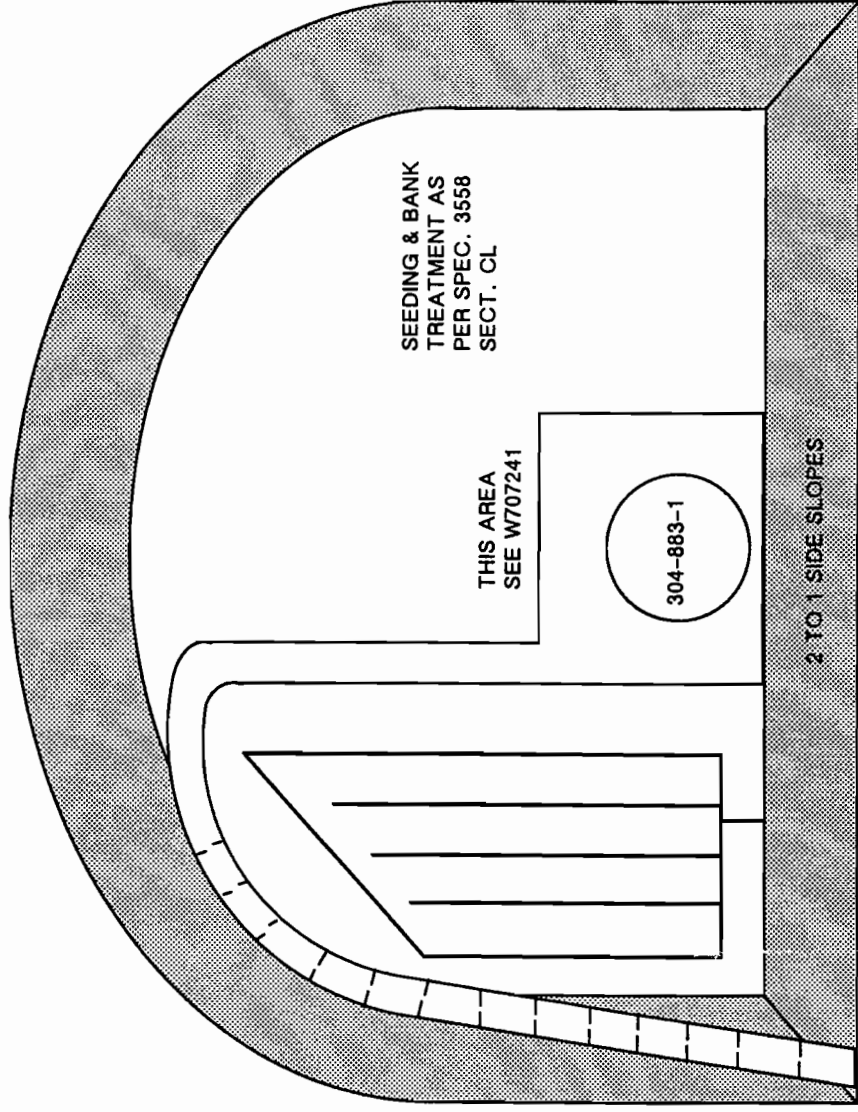
FIGURE 1: PLAN VIEW OF K-REACTOR BASIN

RETENTION BASIN LINER

Three reactors are currently part of the Tritium production facility at Savannah River Site. Currently all three reactors are shutdown. The effluent basin project described in this paper is part of the K Reactor complex. The lining and cover work performed on this basin was performed as part of the restart of K Reactor. A plan view of the K Reactor effluent basin is shown on Figure 1. Having a total acreage of 4.4 acres, the basin has a distinct horseshoe shape and a total containment volume of 48M gallons. That portion of the basin floor containing the percolation drain field is shown on Figure 1 and comprises 44,800 square feet. A profile view of this basin is shown on Figure 2. The 0.5M gallon storage tank has a diameter of 72 feet and a height of 17 feet. The effluent discharge pipe feeding this tank has a diameter of 48 inches and is elevated on timber columns.

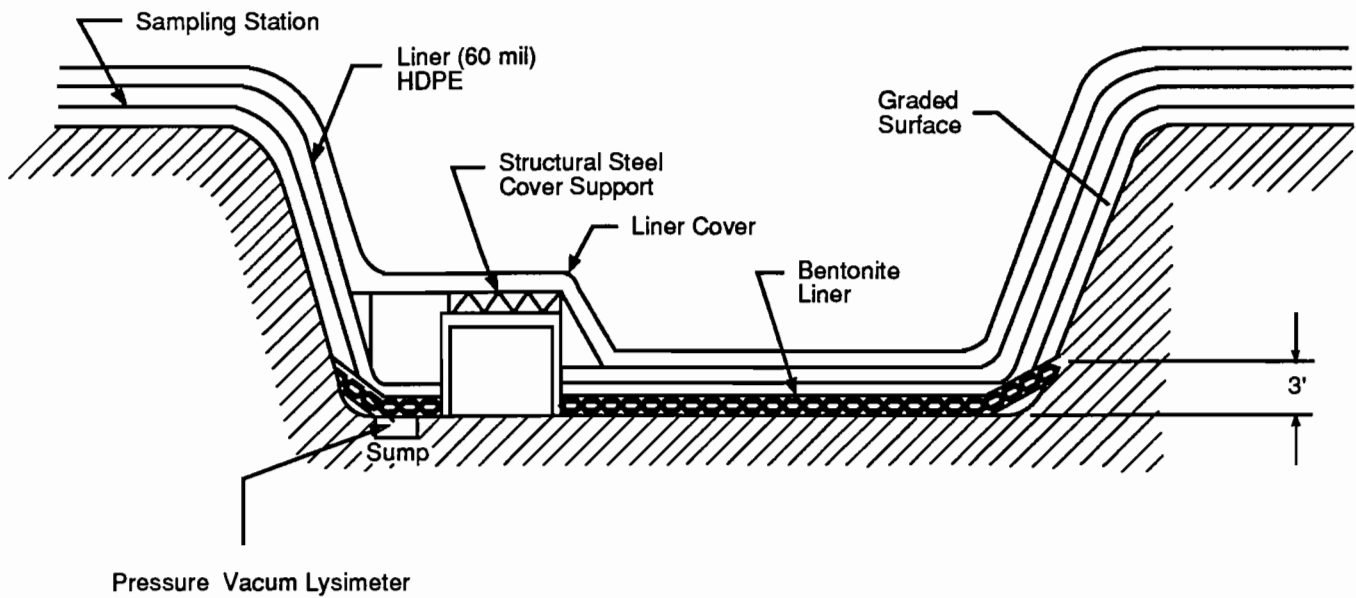
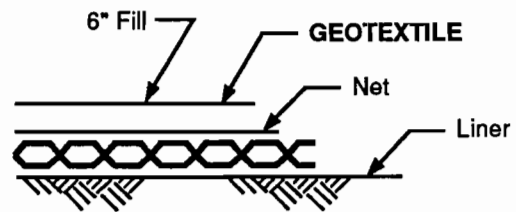
Figure 3. Profile Basin Liner of Retention Basin Liner Project

COMPOSITE BASIN LINER SYSTEM CONCEPT

(ONE LAYER BENTONITE BOARD
ONE LAYER HDPE
AND COVER)

The liner beneath the bottom of the basin can be verified only by measuring the amount of water leaking through the system. A leak detection layer was created beneath the composite liner by installing a geonet and second geomembrane beneath the composite liner. The amount of liquids entering the leak detection system is monitored using two lysimeters placed in sumps beneath this detection layer. A profile of this total bottom liner/leak detection system is shown on Figure 3.
