# Field evaluation of geosynthetic protective cushions: Phase 2

A follow-up to the authors' 1996 field test helps to further define recommendations for geosynthetic-cushion selection.

By Gregory N. Richardson and Sam Johnson

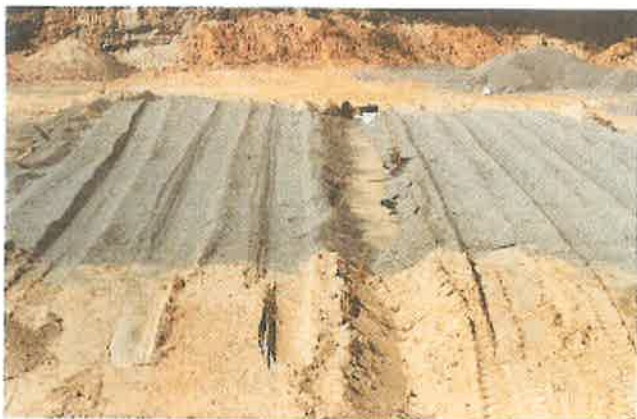
**Photo 1.** Well-defined ruts caused by a loaded dump truck mark the traffic lane.

As shown on **Figure 1**, the dump truck followed two traffic lanes over each geomembrane unit. This compacted the stone depth to a 1 to 3 ft (30 to 90 cm) layer above the geomembrane. Each lane was subjected to 100 passes of a loaded dump truck moving at approximately 5 mph. The traffic lane was demarcated by the well-defined ruts that quickly developed (see **Photo 1**). Rut depths in Phase 2 were similar to those experienced in Phase 1 trafficking. Note that this rutting was due exclusively to the lateral movement of the stone and not to furrowing of the subgrade soils. The rutting resulted in reported cover-stone depths which are conservative in that they are based on the as-constructed geometry and not the post-traffic geometry.

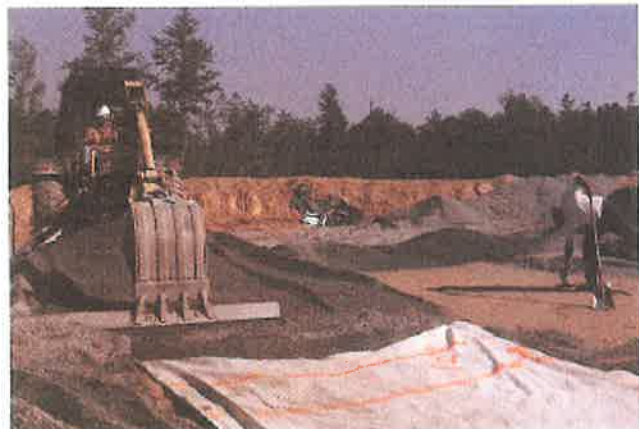
Photo 2. A modified screed was used to remove aggregate without damaging underlying samples.

In Phase 2, geomembrane recovery was made more difficult by the need to avoid damaging the geotextile-survivability samples. The stone within approximately 2 in. of the survivability samples had to be removed by a small backhoe modified with a "screed" welded to the teeth of the bucket, as shown on **Photo 2** (p. 46). The screed was used to carefully scrape thin layers of gravel from the test fill. The balance of the stone over the survivability samples was removed by hand shoveling.

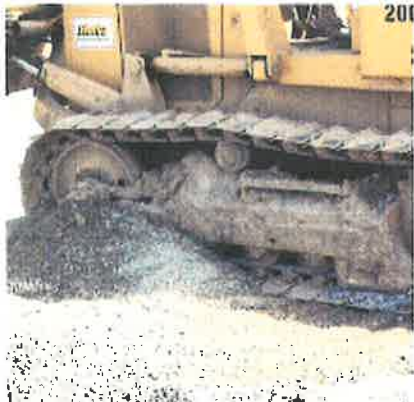
**Photo 3.** A D7 dozer makes a typical stone-placement maneuver.

Supplemental geosynthetic-cushion sections were loaded using a D7 dozer that tracked to the center of the section and made a single 90-degree turn in place. It then tracked and turned 90 degrees to move off the section (see Photo 3, p.49). This single-turn loading is a typical maneuver that a dozer operator may use during stone placement. Currently, most specifications discourage such turns, but these rely on third-party inspectors to control or limit such activity. Field measurements indicated that, after the single turn, the initial 12 in. vertical separation between the tracks and the geomembrane was reduced to 2.5–4.0 in.
