## Surface impoundment rehabilitation

In a previous Designer's column (April 2002), the second author presented an evaluation of the failure of a surface water reservoir. This reservoir had failed during post-construction hydrostatic testing and had not provided a single day's service for the water district. As detailed in that article, the failure was the result of a combination of unstable subgrade soils and design assumptions that did not manage seepage through the geomembrane and steel battening system. At the time Red Mesa Consulting Inc. was retained to provide remedial design services, the water district was approximately two years behind schedule in its plans for expansion. To further aggravate circumstances, water supply reservoirs upgradient were experiencing severe decreases in storage because of persistent drought conditions. This article presents the rehabilitation of the reservoir that is now in service and functioning in accordance with the design.

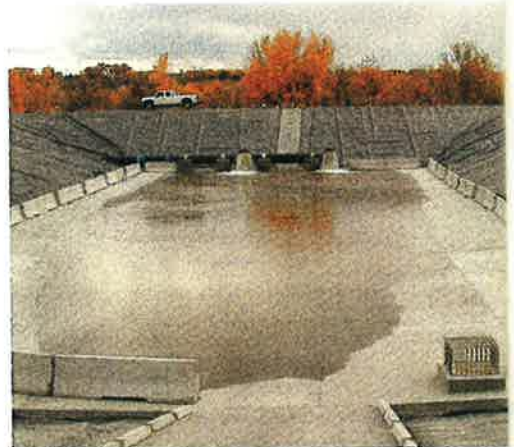
**Photo 1.** The completed access ramp and base clear the way for the geosynthetic redesign of the structure.

To allow the water district access to the interior of the reservoir for clean out, a concrete ramp and base slab were placed on the liner system. A 12 oz nonwoven was used as a cushion between the concrete and the underlying liner. This also provided for drainage from beneath the concrete access system. The access ramp into the reservoir bottom is supported by both adequate interface frictions in the underlying liner system and from buttressing by the concrete base slab. **Photo 1** shows the completed concrete access ramp and base. Note that "Jersey" style barriers were incorporated at the perimeter of the concrete base liner to protect the exposed HDPE side slope liner from damage during future sediment clean out operations.

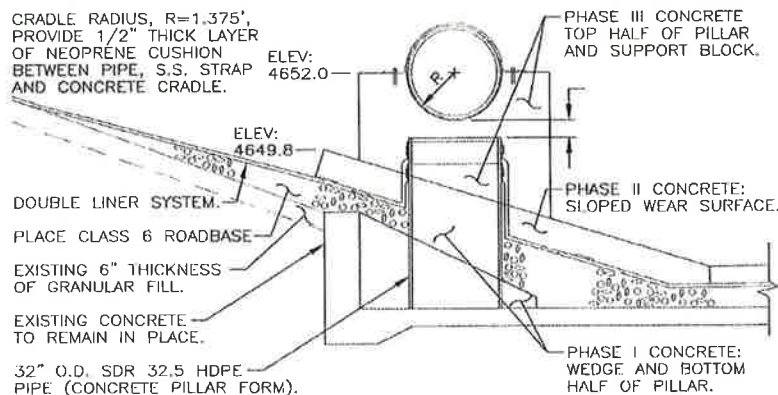
**Figure 1.** Inlet pipe support detail.

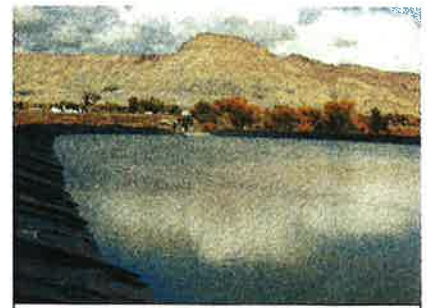
**Photo 2.** The rehabilitated reservoir is finally able to begin serving the water district.

Reconstruction of the reservoir began in late July 2002 by Nielsons SKANSKA. The liner system was installed by Simbeck & Associates. Redesign, construction oversight and CQA for the rebuild was provided by Red Mesa Consulting Inc. Construction was completed in early November 2002. The rebuild of the impoundment cost the water district approximately \$534,000. The Colorado State Engineer's Office granted acceptance of construction on 10 January 2003. Photo 2 shows the reservoir full and in service today.

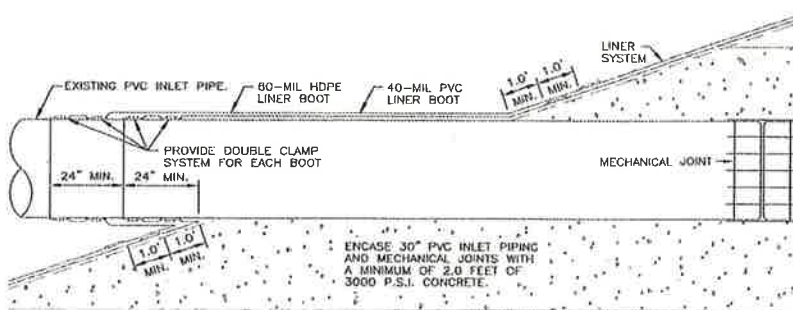
However, the large 30-in. inlet pipe penetration was not protected by concrete. As shown on **Figure 3**, the performance of the pipe boots around the pipe was verified by using two neoprene cushion and stainless steel strap seals on each liner boot such that they could be pressure tested. The pipe was also placed in a concrete block to limit its movement and any potential erosion near the pipe.

**Figure 3.** Inlet pipe boot detail.
