BY GREGORY N. RICHARDSON, Ph.D., P.E.
LEON H. BEHR, JR.

Survivability of Subgrade Separators

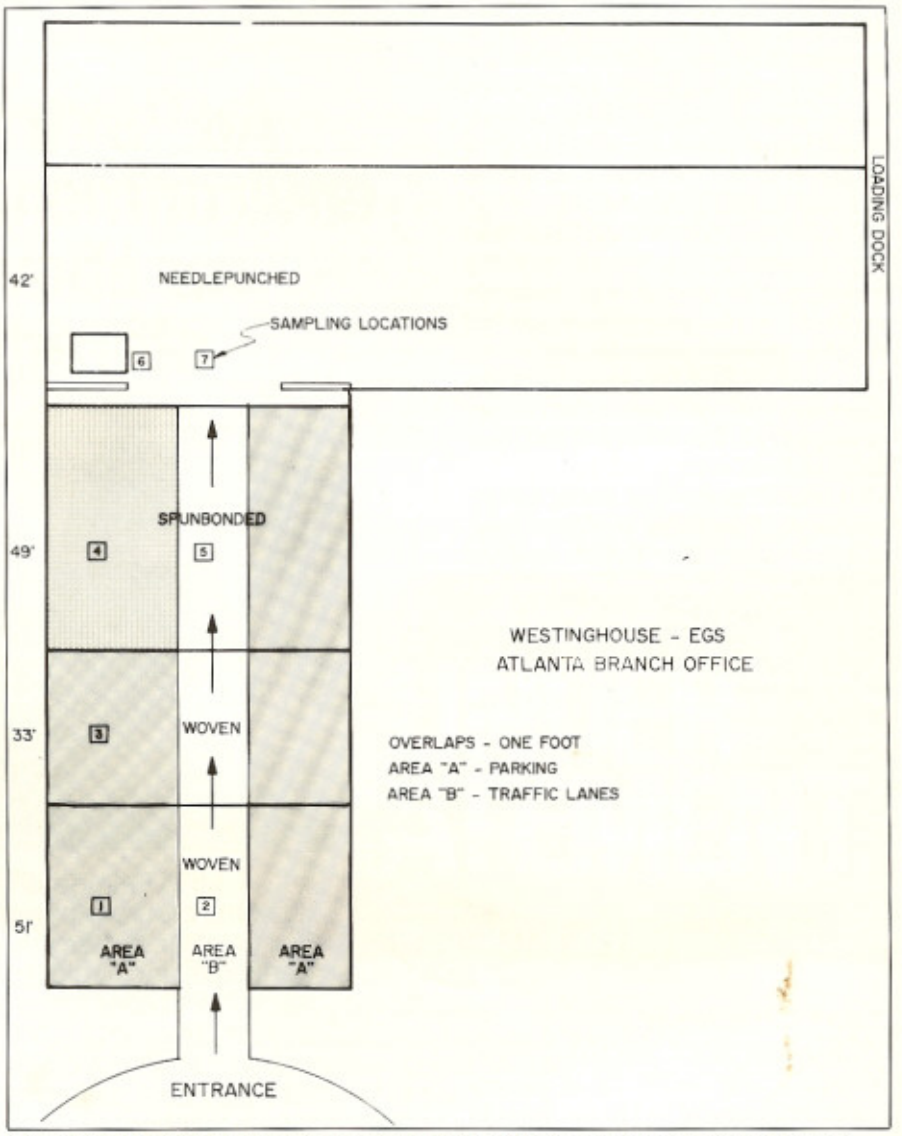
The fabrics cover two distinctly different traffic zones as shown in Figure 1. Area A was used primarily for parking, while area B was subjected to traffic consisting of delivery trucks, various construction vehicles, lowboys carrying drill rigs, and client and employee automobile traffic.

Figure 1: The fabrics cover two distinctly different traffic zones. Area A was used primarily for parking. Area B was subjected to traffic consisting of delivery trucks, various construction vehicles, lowboys carrying drill rigs and automobile traffic.

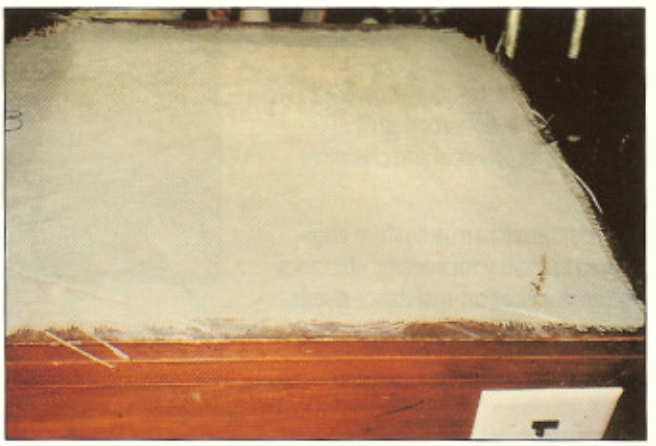
Figure 7: There was no evidence of subgrade pumping at this location.

woven fabric being exhumed from Location 3. Again, the fabric is in excellent condition as shown in Figure 7. There was no evidence of subgrade pumping at this location.

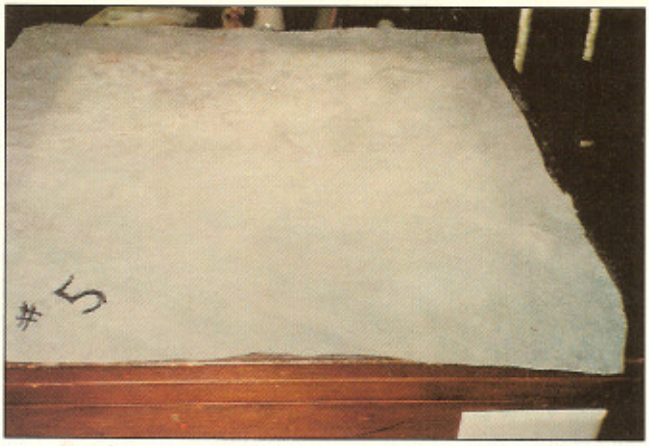
Figure 9: Nonwoven fabric samples from location 5 showed no problems.

Figures 8–11 show non-woven fabric samples from locations 5 and 7. An overlap was encountered at location 7, but there was no apparent performance problem caused by the overlap. As in the previous locations, both the fabrics and the pavement structures were in excellent condition.

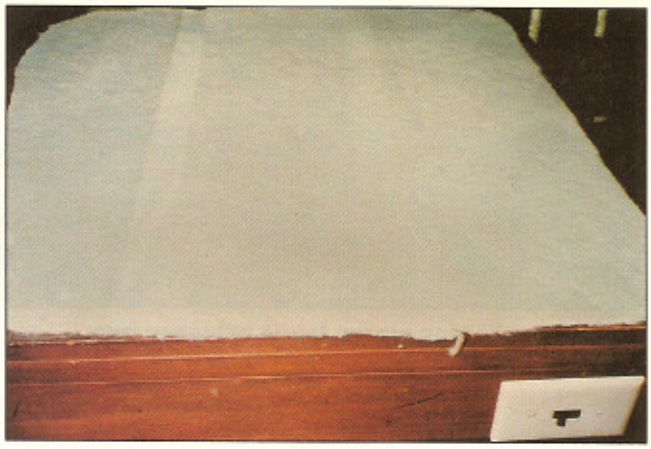
Figure 11: Needle-punched nonwoven fabric (exhumed from location 7) on a light table.

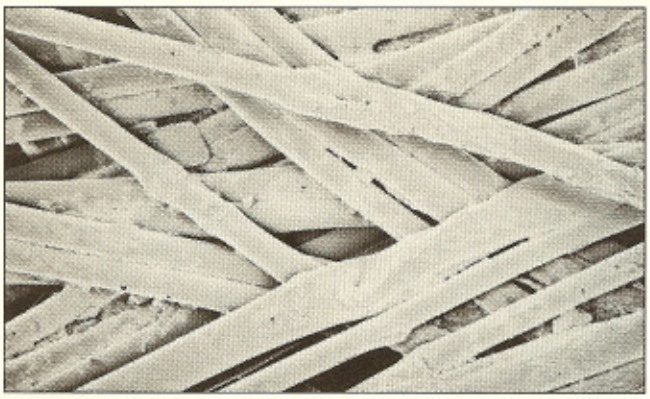
Figure 12: A scanned electron photomicrograph of exhumed spunbonded nonwoven fabric from location 5.

The photomicrographs of the woven fabrics show some cracking and splitting of yarns, but no complete failure of the yarn systems is indicated. Also, no punctures or yarn movements which would lead to a degradation of hydraulic properties is indicated by the photographs.

The nonwoven fabrics are also in good condition as shown by the photographs. Some crushing of the fibers has occurred in the fabric in Location 5, but no failure of the system is shown.

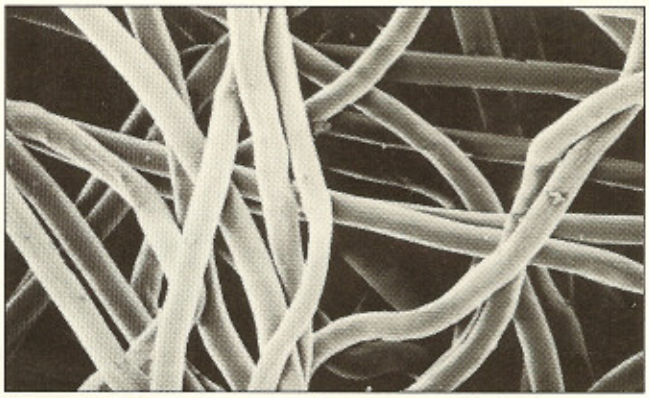
Figure 13: Needle-punched nonwoven fabric from location 7.
