# DESIGNER'S FORUM

## Fundamental mistakes in slope design

By Gregory N. Richardson

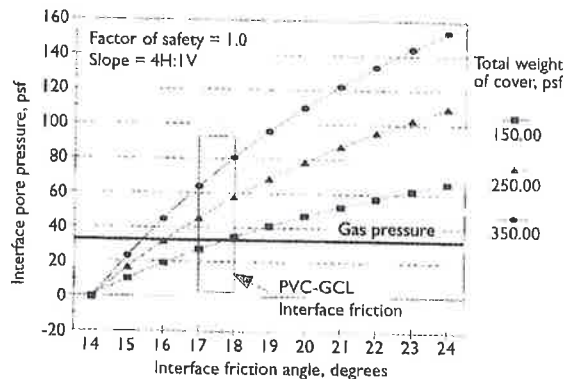
Figure 1. Allowable interface pressure

Figure 1 shows this equation for the 4H:1V slope,  $FS = 1$ , and a range of interface frictions, soil cover weights and excess gas or pore water pressures. Recall that the actual failure occurred between the geomembrane and the GCL, and that the gas pressure was approximately 31.2 psf. Thus, the slope would have been stable if the in-

interface friction was greater than 17.5 degrees. Unfortunately, the measured interface friction angle was only 17 to 18 degrees, and a sliding failure resulted during placement of the sand drainage layer.

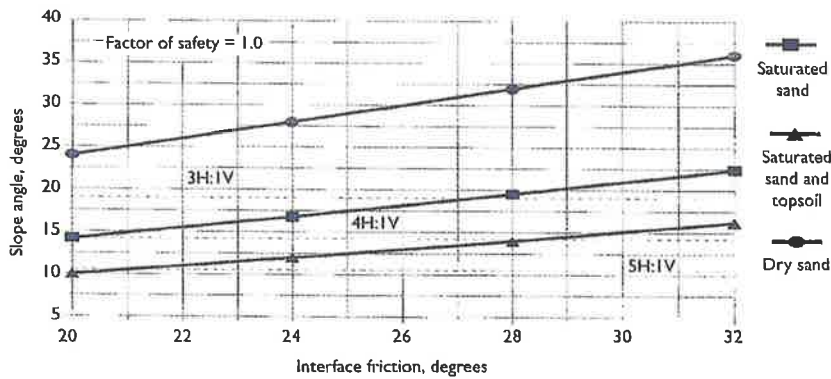
**Figure 2.** Slope vs. interface friction

The silty sand had a friction angle of 31 degrees and was very fine (more than 30 percent nonplastic fines). The permeability of the silty sand was  $1 \times 10^{-4}$  cm/sec. A HELP analysis was performed to evaluate the geonet design and the moisture in the vegetative-support layer. The analysis indicated an acceptable inflow into the geonet and little change in the moisture content of the silty sand vegetative-support layer. Using the same slope stability analysis previously presented, Figure 2 shows the effect of saturating the sand and topsoil on the sliding factor of safety. The higher the saturated zone is allowed to rise in the cover profile, the lower the factor of safety. Given that the interface friction between the geotextile and the silty sand is less than the sand's shear strength (e.i.,  $\leq 30$  degrees), the factor of safety approaches unity for 3H:1V slopes if only the sand is saturated, and 4H:1V if the entire cover section is saturated.
