Active LFG Control: An Unreliable Aid to Veneer Stability

Gregory N. Richardson, Ph.D., P.E.
Stacey A. Smith, P.E.
Pieter K. Scheer, P.E.

The First Pan American Geosynthetics Conference and Exhibition
2-5 March, 2008
Cancun, Mexico

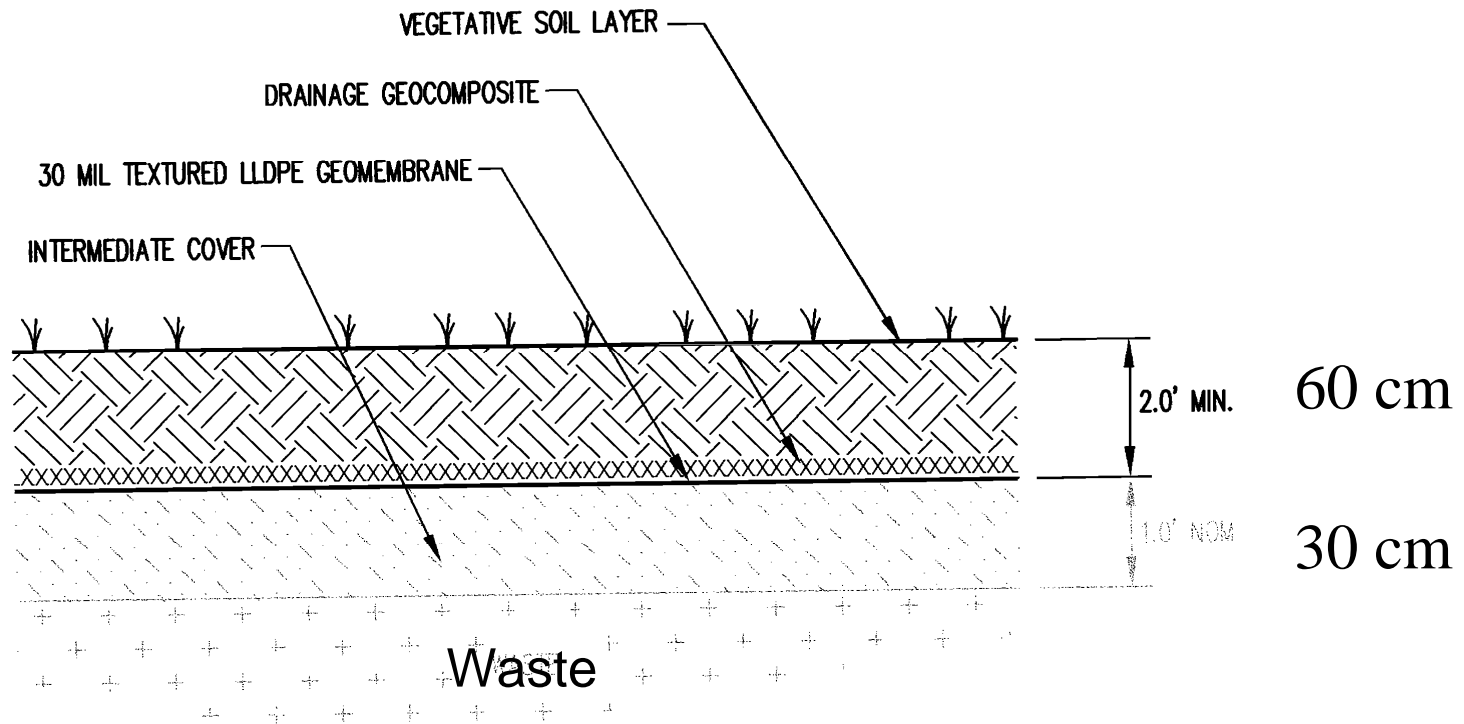
Typical Geosynthetic Final Cover System

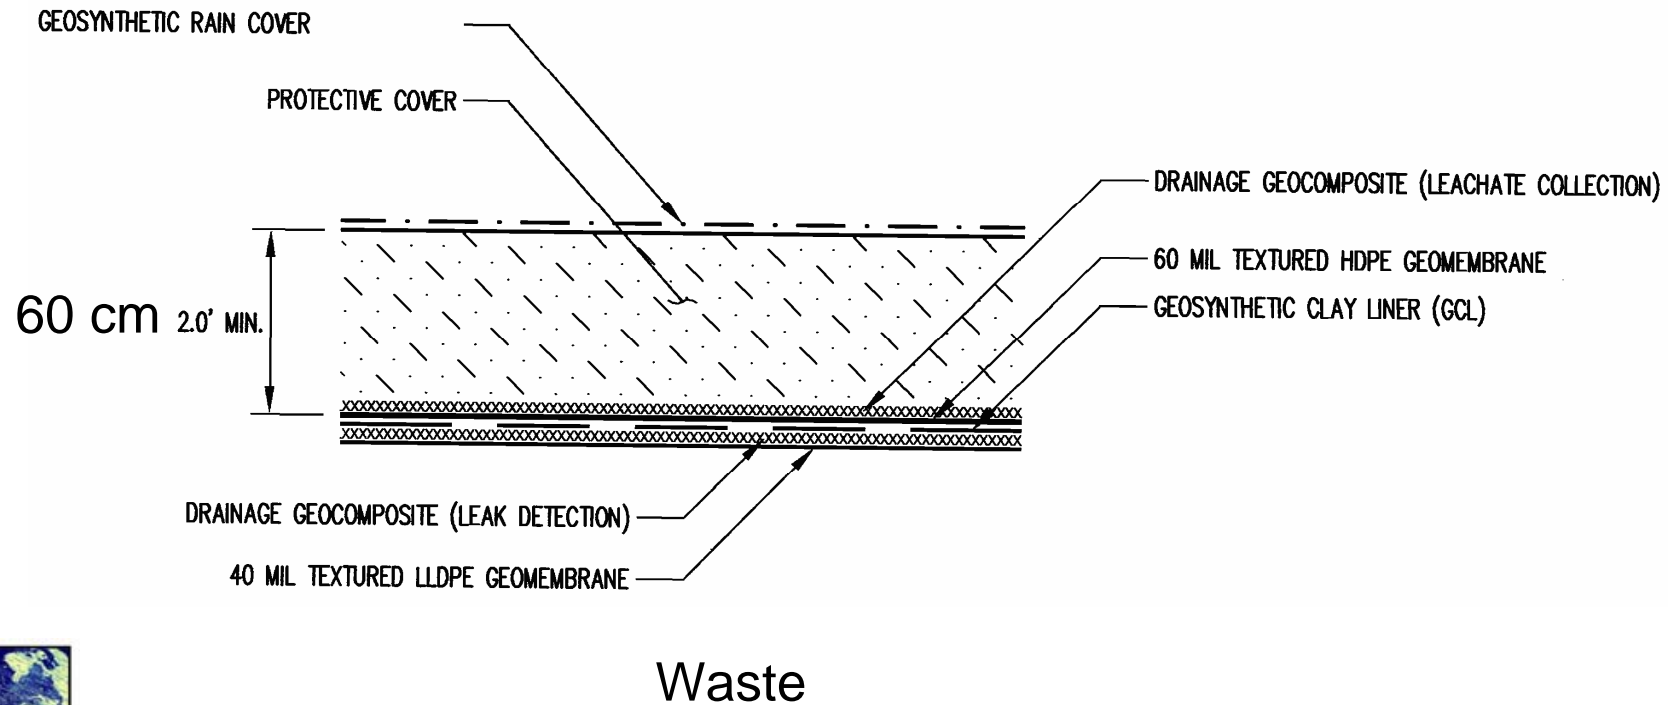
Typical Piggyback (Waste Over Waste) Liner System

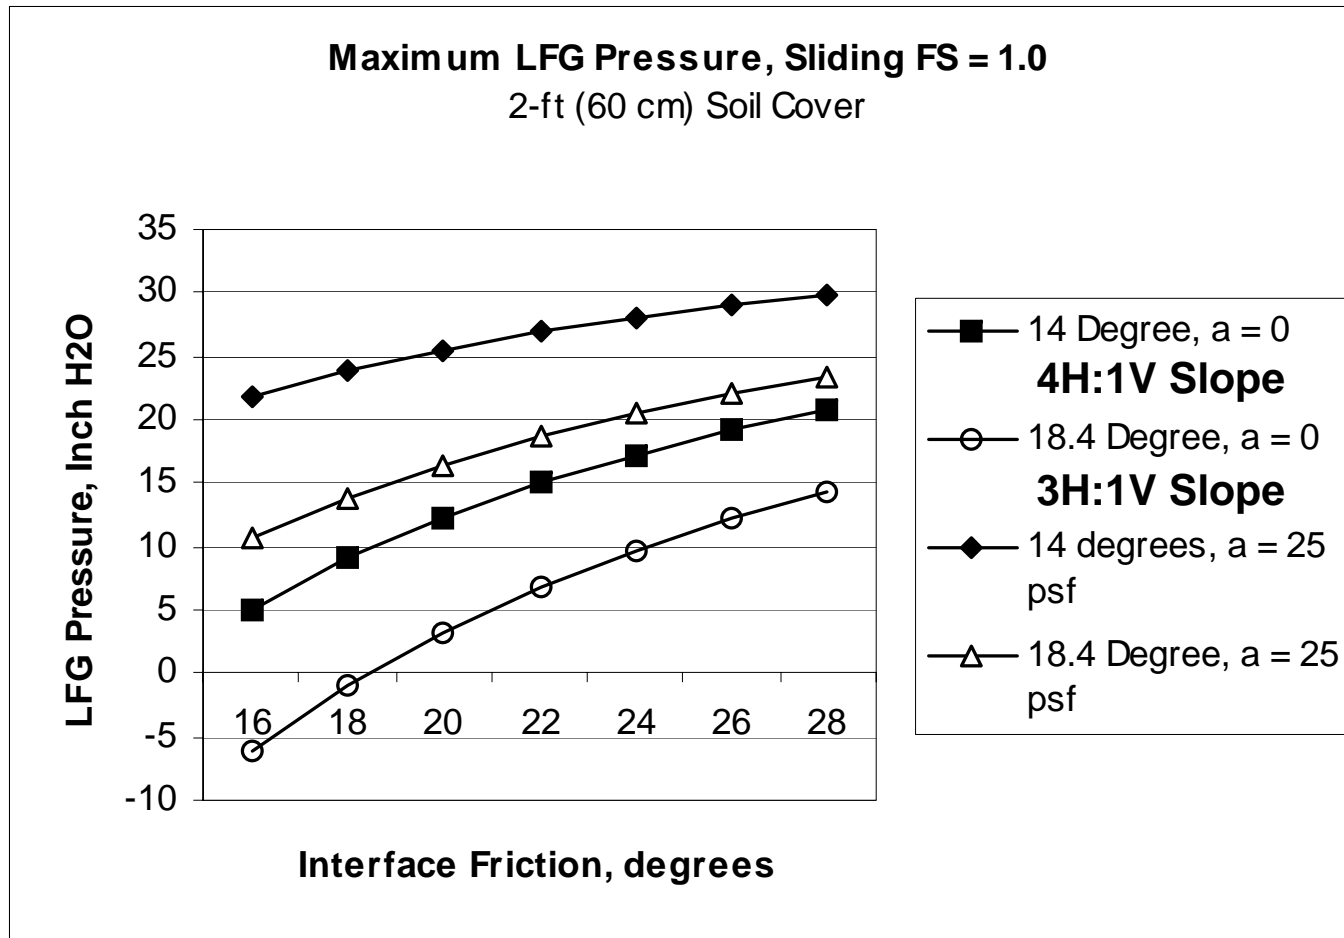
$$FS = \frac{(W - u_{LFG}) \cos \beta \tan \delta + a}{W \sin \beta} \quad \text{Eq. 1}$$

- $W =$ weight of final cover system above the GM (kg/m^2),
- $u_{LFG} =$ LFG pressure (kPa)
- $\beta =$ slope angle (degrees)
- $\delta =$ interface friction angle (degrees)
- $a =$ interface adhesion (kPa)

LFG Pressure at Limit of Sliding Stability

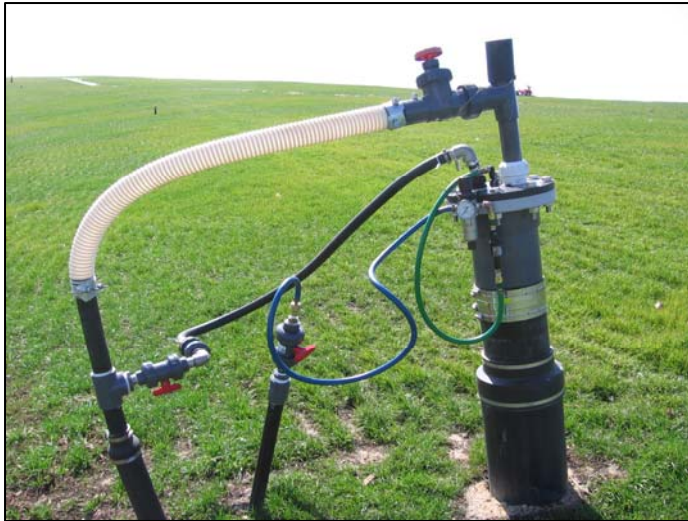
While active LFG systems rely on a regularly spaced network of gas wells.....

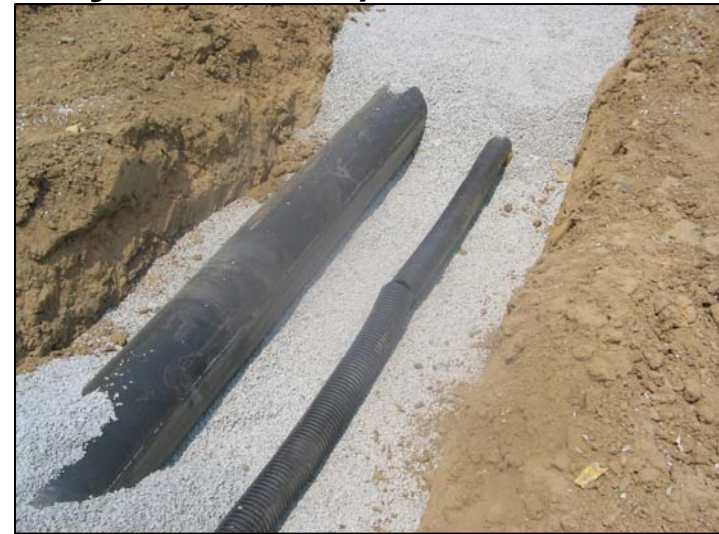
Passive LFG systems are systems that rely on gravel “French drains” or area collectors placed at/near the surface of the waste.

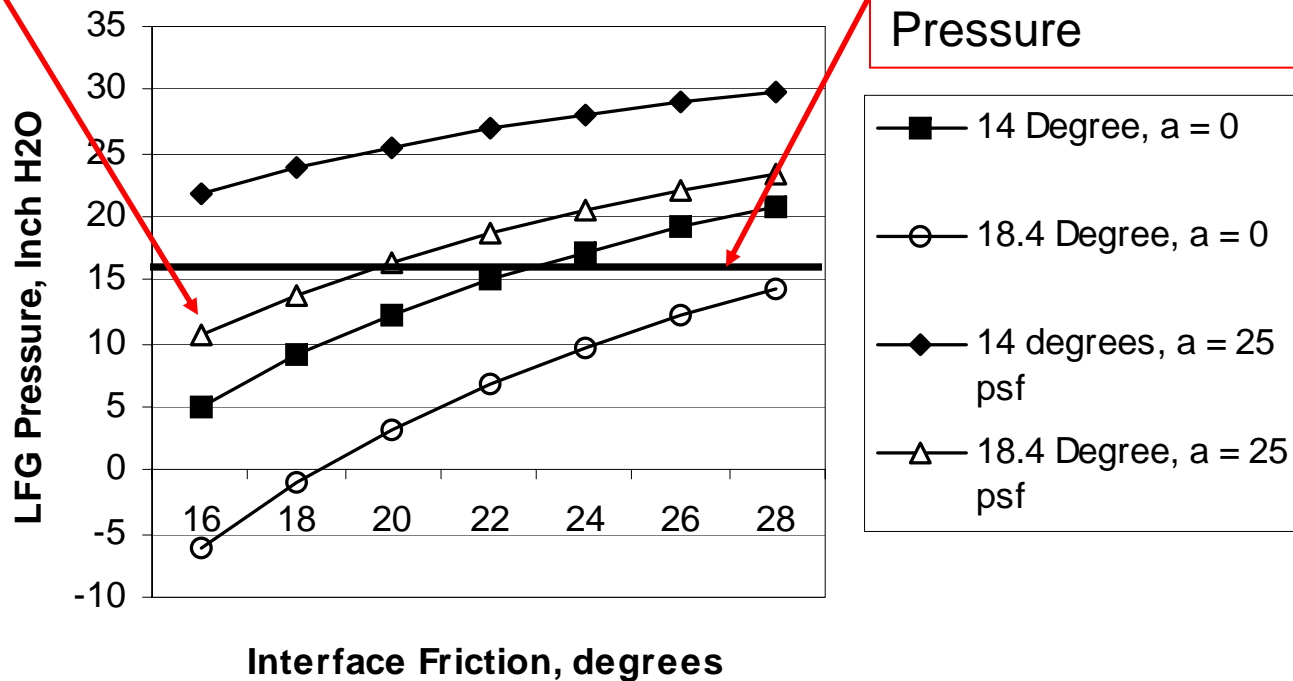
PVC-GCL
Interface Shear
Strength

Maximum LFG Pressure, Sliding FS = 1.0
2-ft (60 cm) Soil Cover

Maximum LFG
Pressure

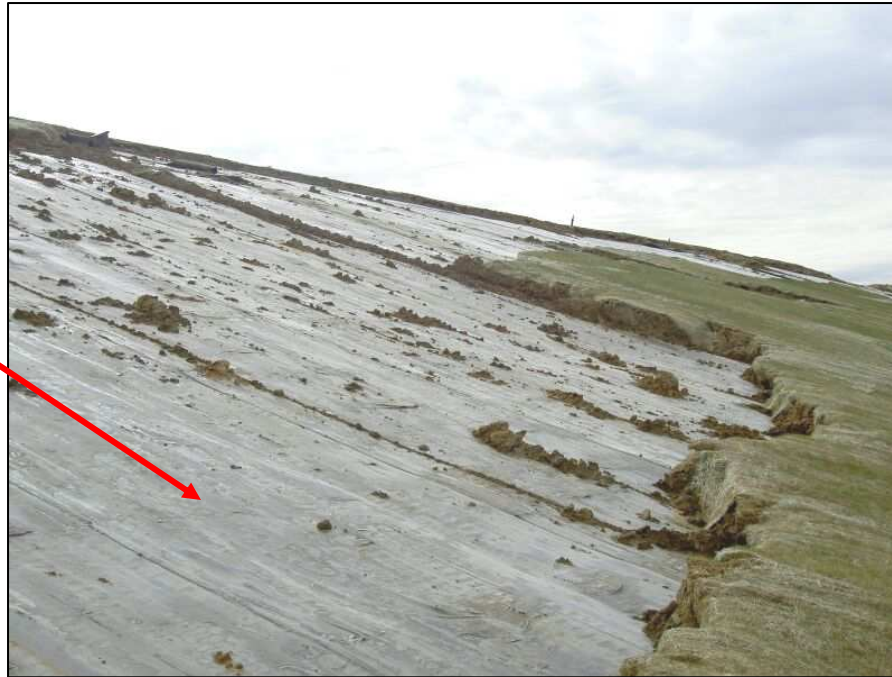
Exposed
GCL

Final Cover System on 3H:1V slope with components (top-down):

- 2-ft (60 cm) topsoil and vegetative soil;
- 8 oz/sy (272 g/m²) nonwoven geotextile
- Text. LLDPE geomembrane (spikes on bottom/drain surface on top);
- GCL having nonwoven side down, woven side up; and
- 1-ft (30 cm) interim soil cover immediately over waste.

- Failure occurred along LLDPE geomembrane/GCL within a few months of completion of the final cover system. The LLDPE geomembrane used was a structured product with conical spikes on the bottom and a studded drain layer (in conjunction with the nonwoven geotextile) on top.
- At the time of discovery of the failure, the active gas recovery system had been down for about one week for maintenance.

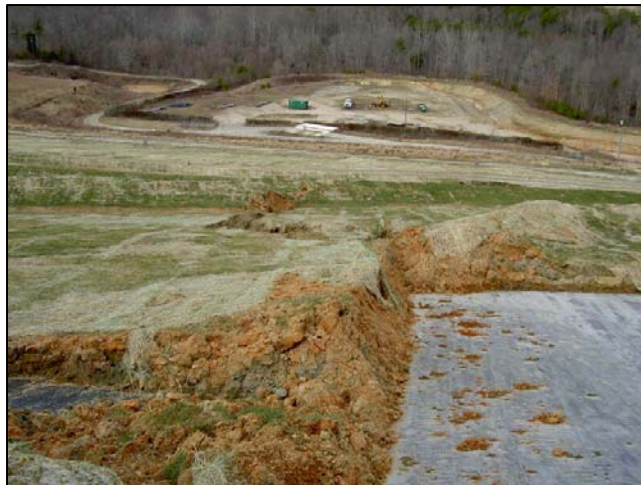
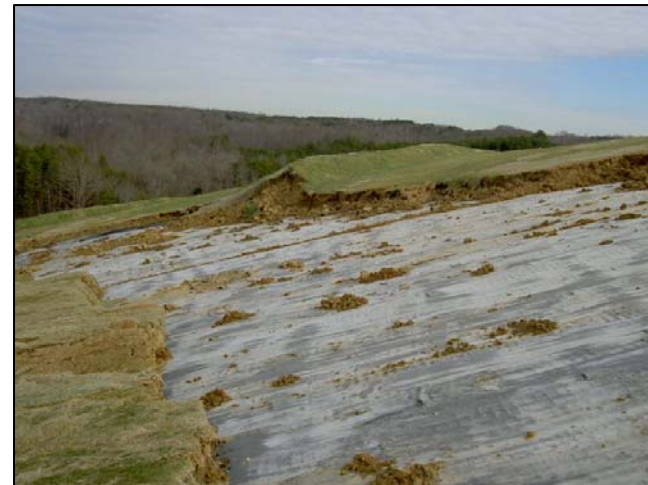
- Pre-construction testing of LLDPE GM/GCL interface ($\phi = 29$ degrees; $a = 0$ psf) theoretically stable ($FS > 1.0$) at < 15 inch- H_2O (3,735 Pa) LFG pressure.
- Post-failure testing of LLDPE GM/GCL interface ($\phi = 23.5$ degrees; $a = 0$ psf) theoretically stable ($FS > 1.0$) at < 9 inch- H_2O (2,240 Pa) LFG pressure.
- The significantly lower interface shear strength was attributed to dragging of the geomembrane downslope during deployment. The dragging reduced the asperity height of the spikes (i.e. dulled the tip of the spike).

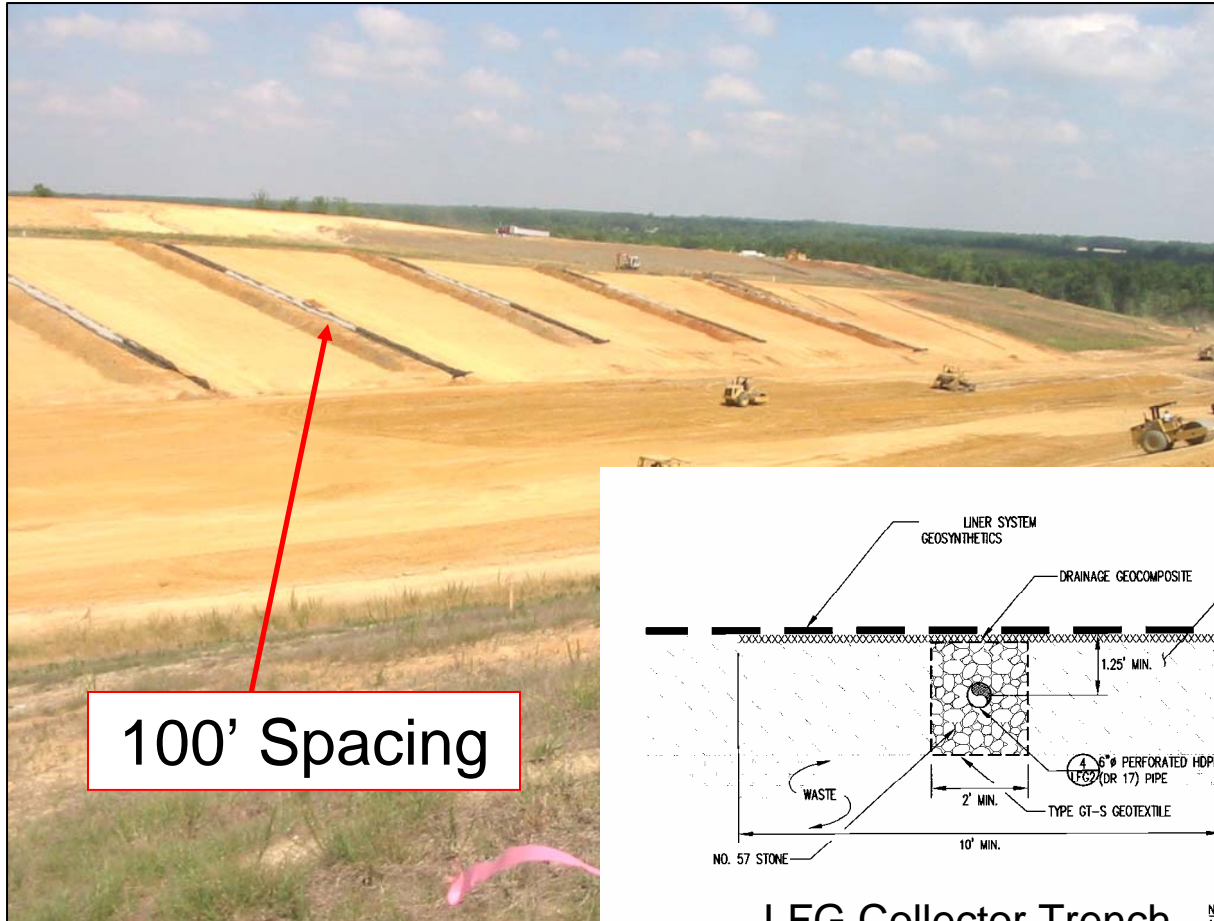
100' Spacing

Contingent Passive Venting Systems: Piggyback Liner System

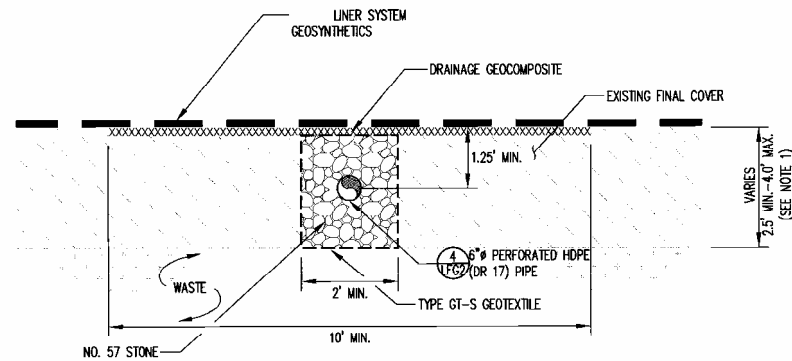
LFG Collector Trench

NOTE:
1. EXCAVATE TRENCH SUCH THAT EXISTING COVER IS BREACHED OR TO A MAXIMUM DEPTH OF 4 FEET.

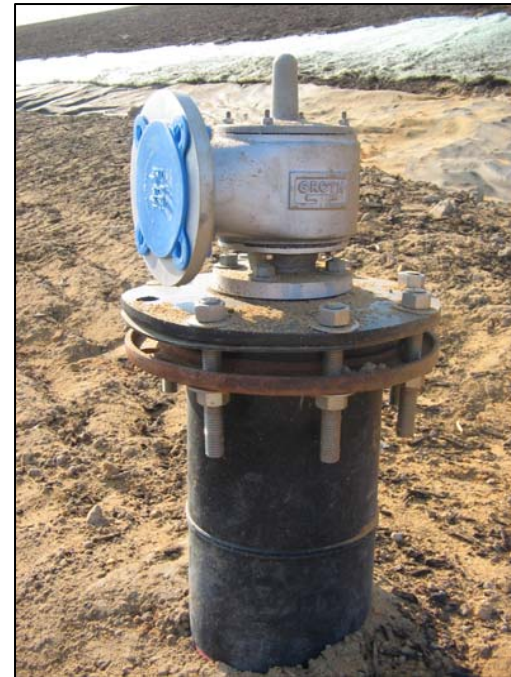
Emergency LFG Relief Vent

- Limit LFG release under normal operations.
- Allow venting of positive LFG pressures.
